# Reaction to fire test report

Test standard: BS 8414-2:2015

Product: [REDACTED] wall system

Job number: RTF230138

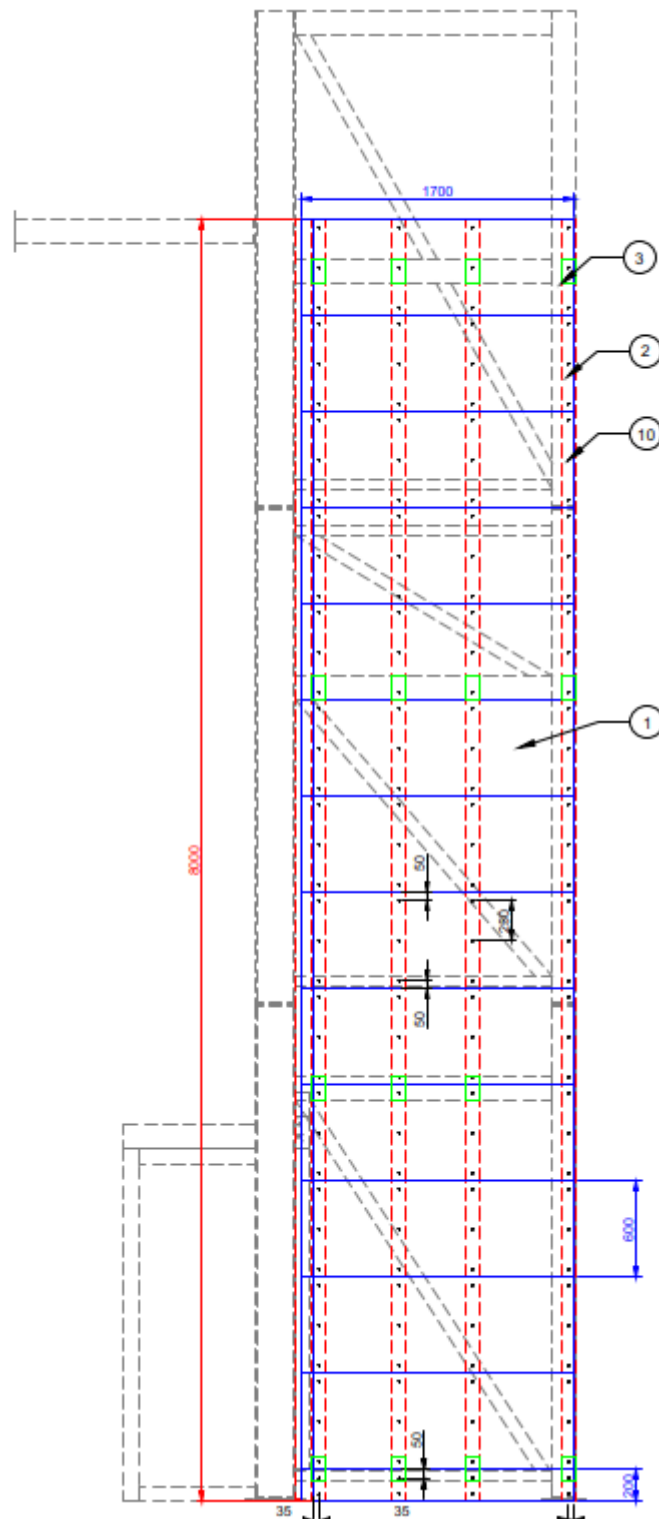
**Figure 2 Panel layout (elevation – wing wall)**

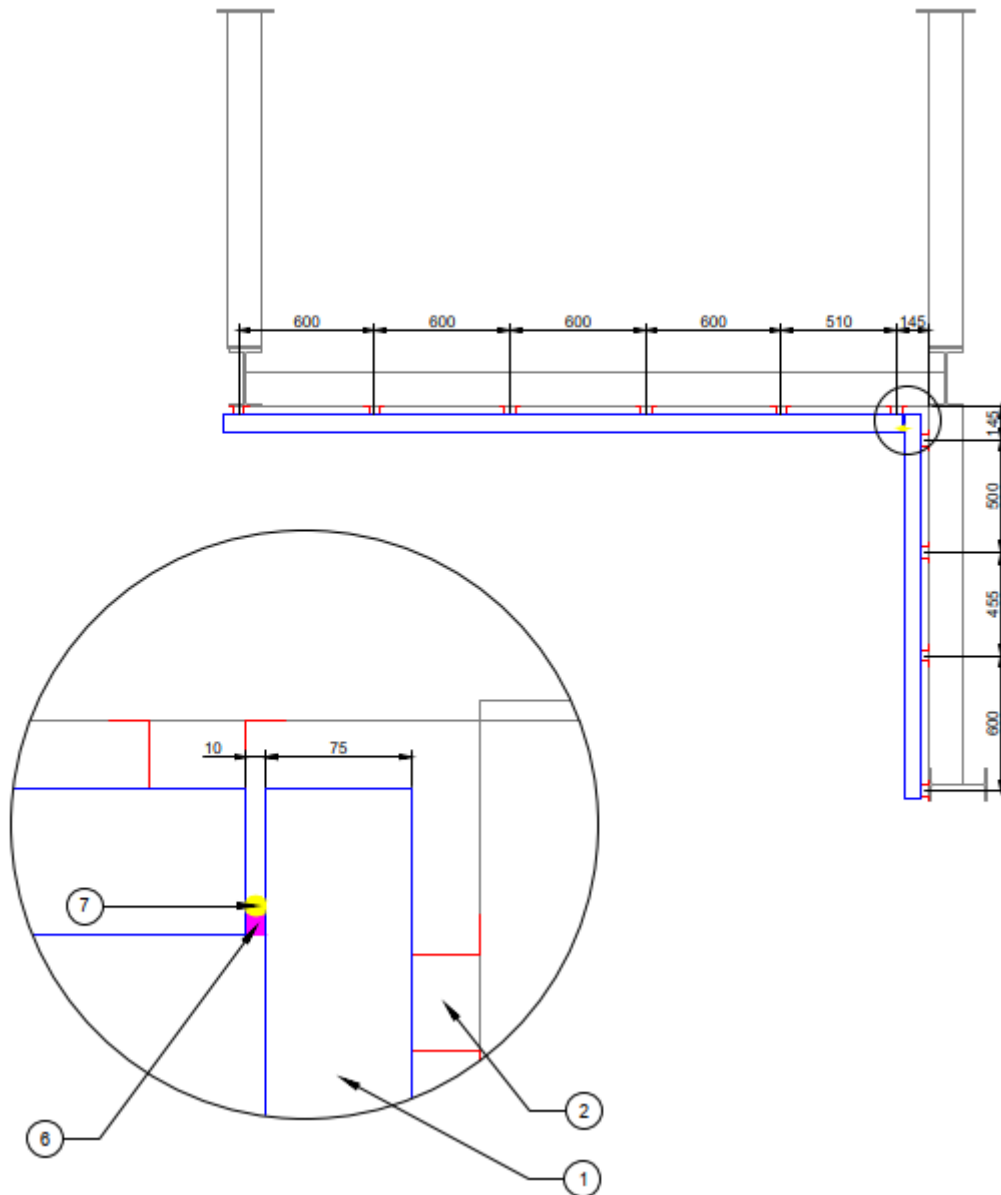
**Figure 3 Horizontal cross-section**

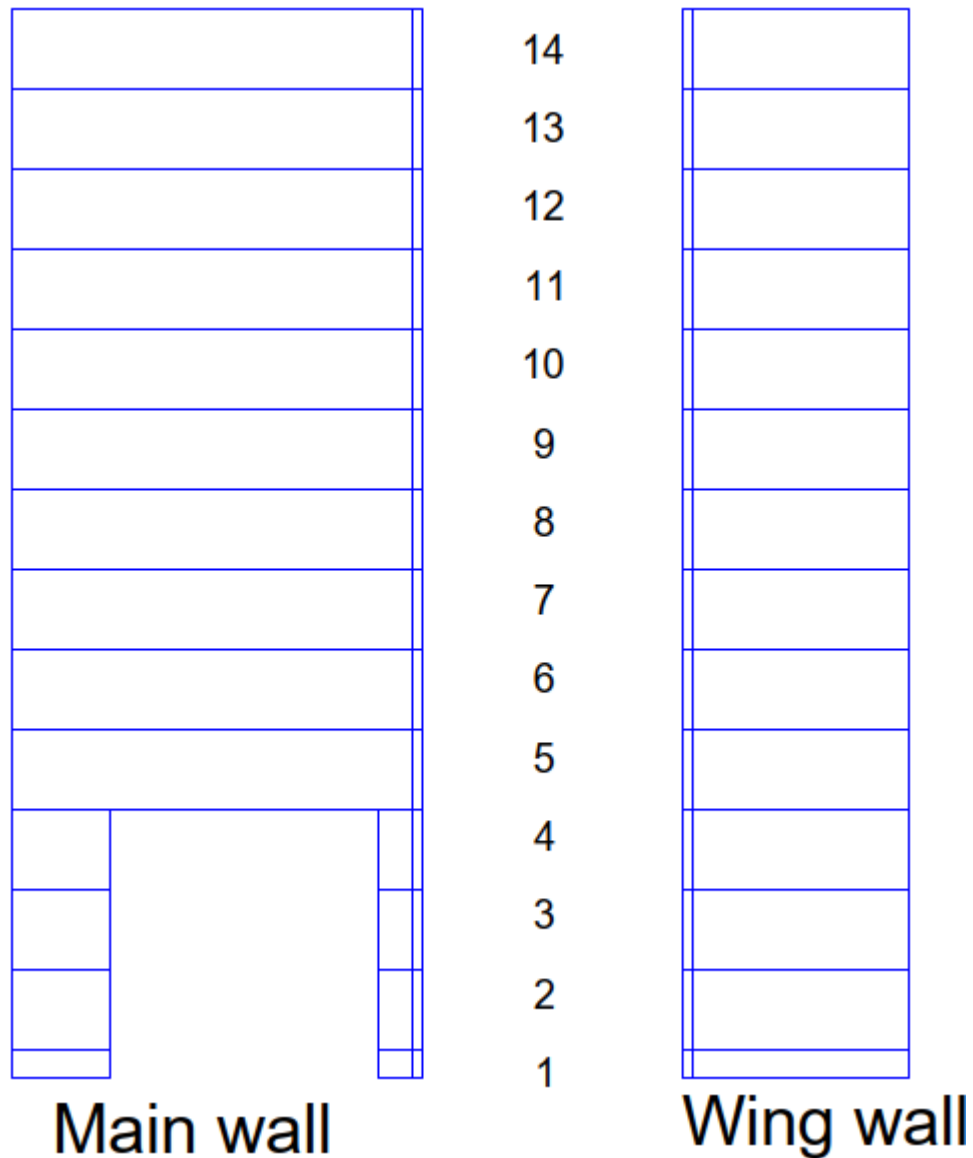
Figure 4 Panel designation (main and wing wall)

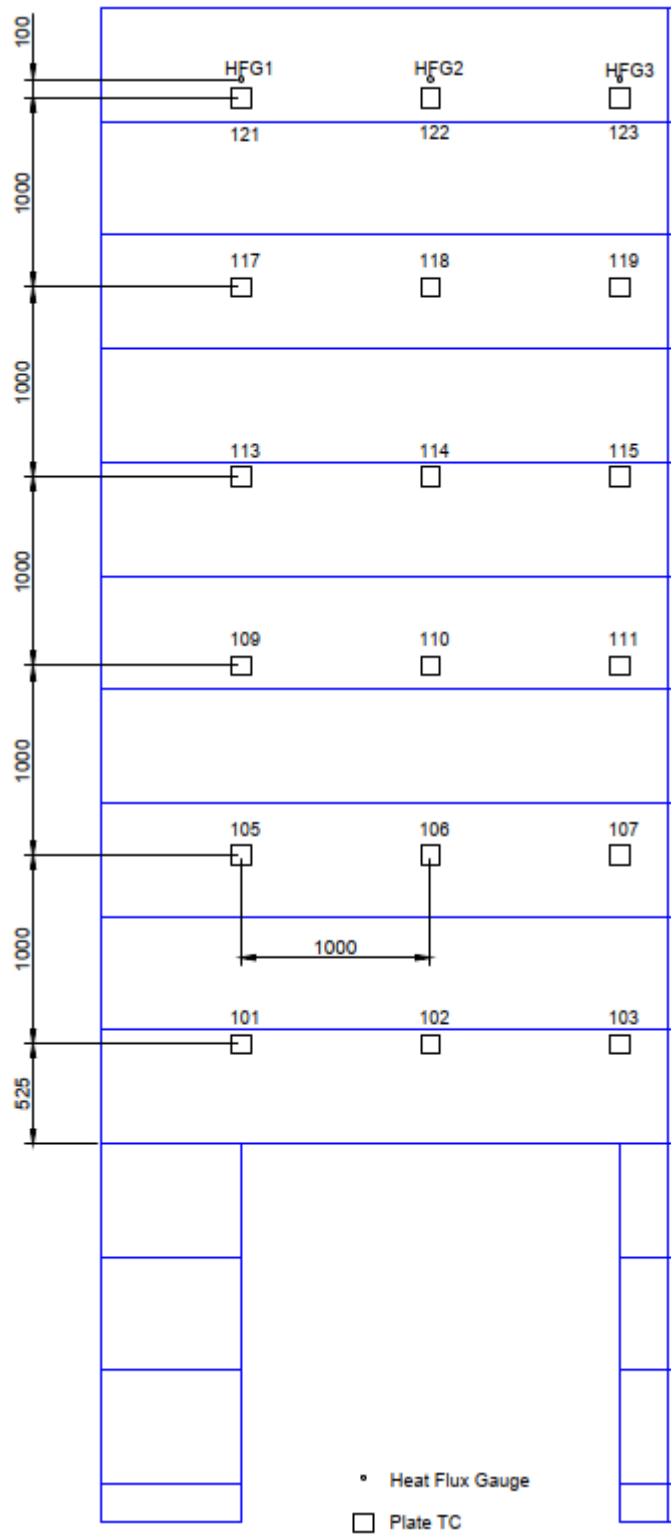
**Figure 5 Main wall – surface instrumentation**

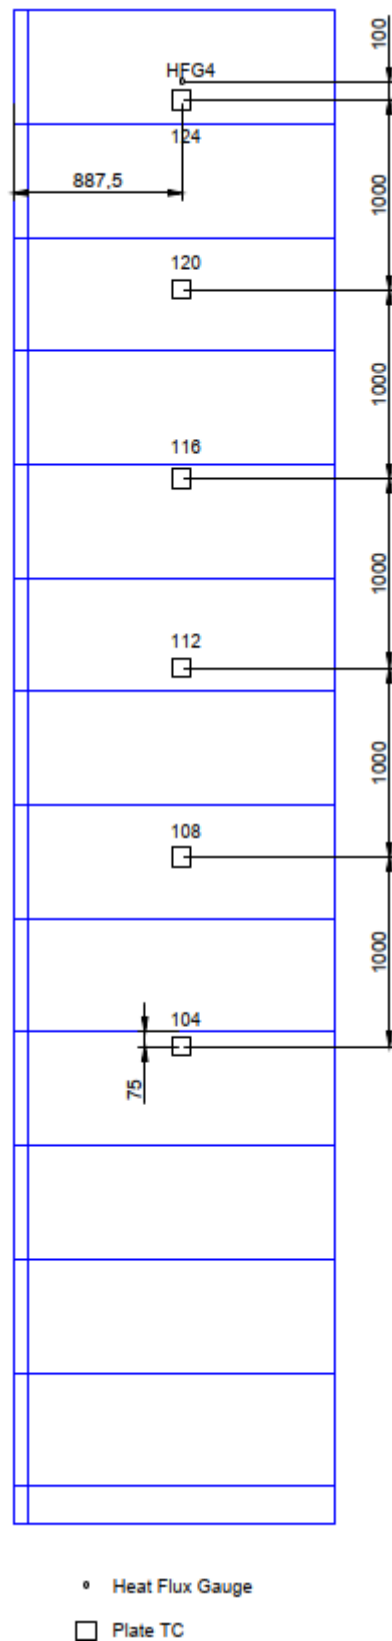
**Figure 6 Wing wall – surface instrumentation**

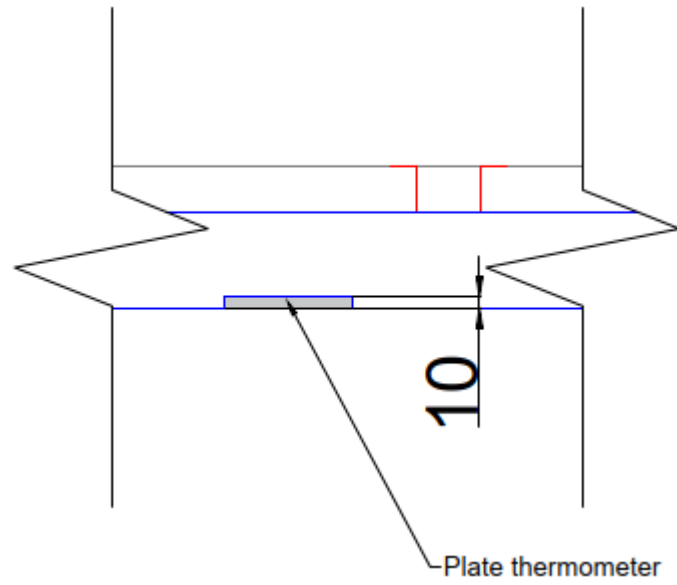
**Figure 7 Horizontal cross section detail – plate thermometer**

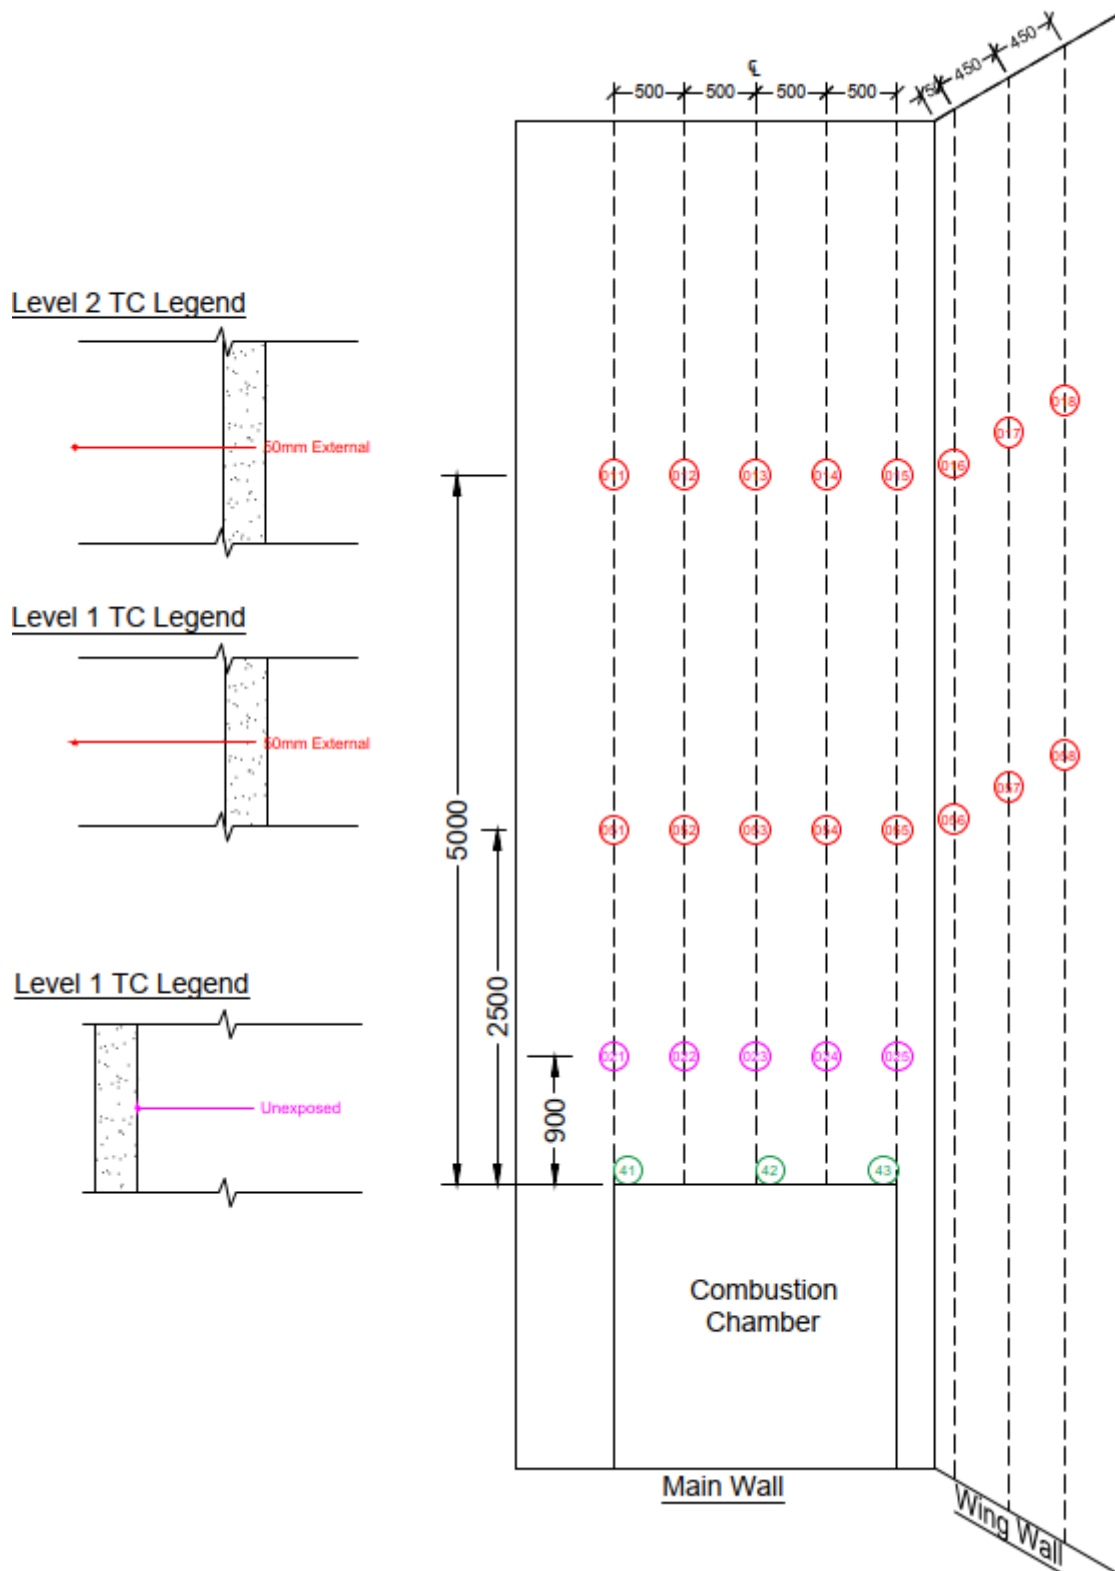
**Figure 8 Instrumentation locations - other (main and wing wall)**

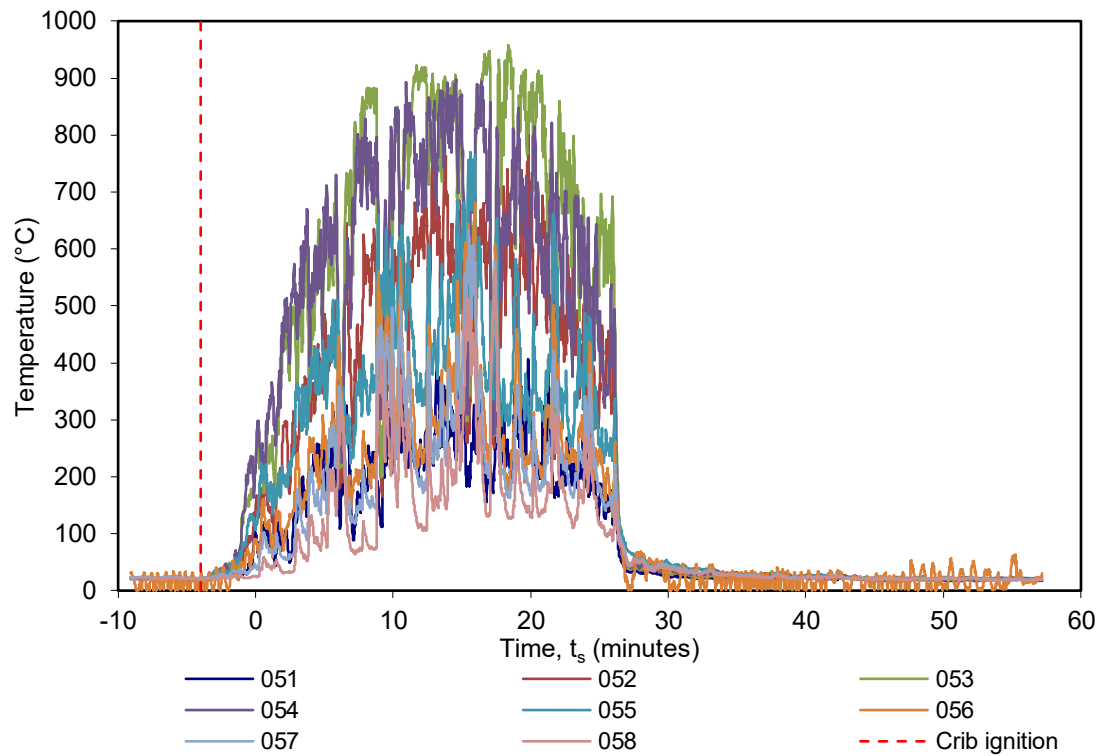
**Figure 9 Level 1, external – temperature vs time**

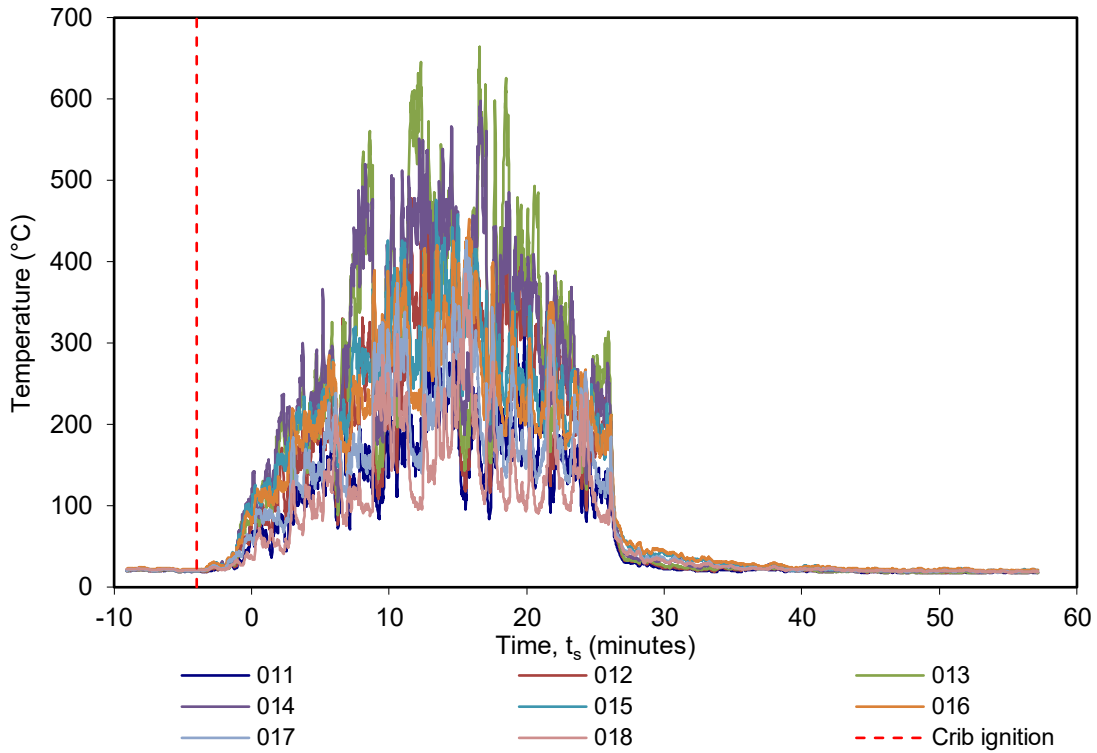
**Figure 10** Level 2, external – temperature vs time

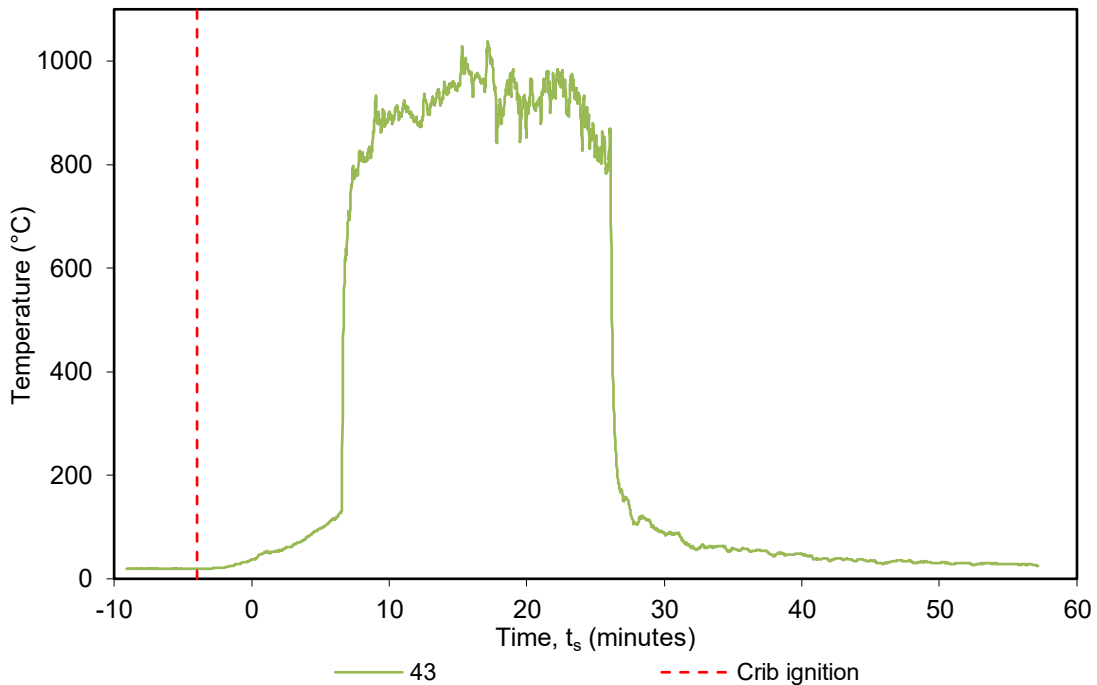
**Figure 11** Underside of chamber lintel – temperature vs time

**Note:** TC 041 and 042 malfunction throughout the test period.

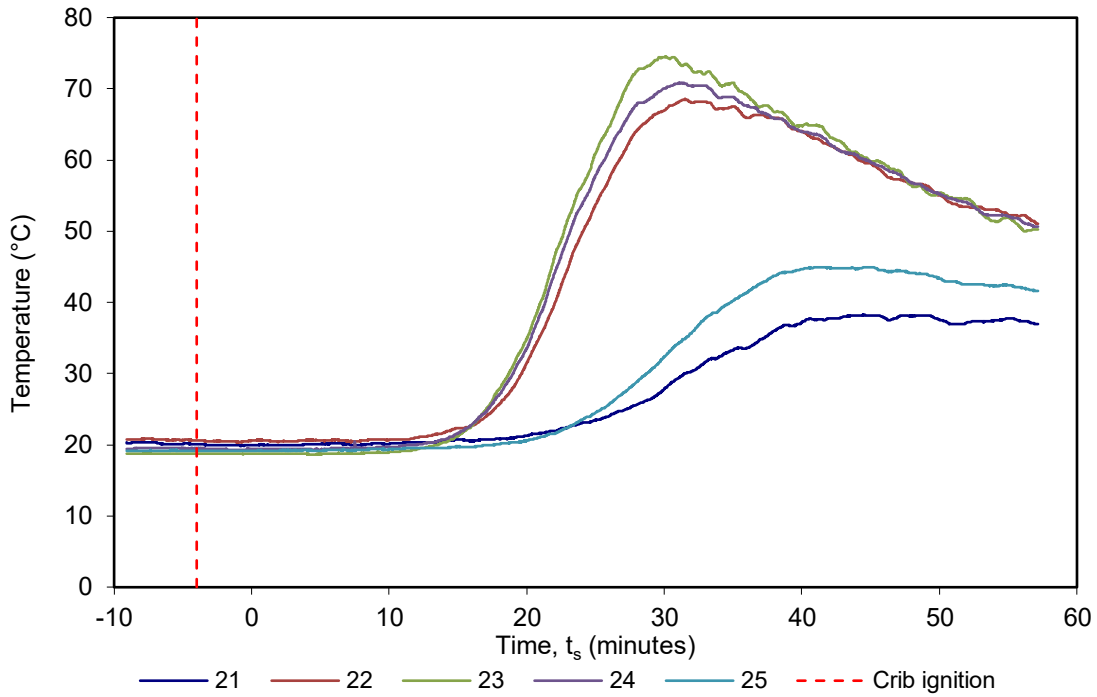
**Figure 12 900mm above chamber opening – temperature vs time**

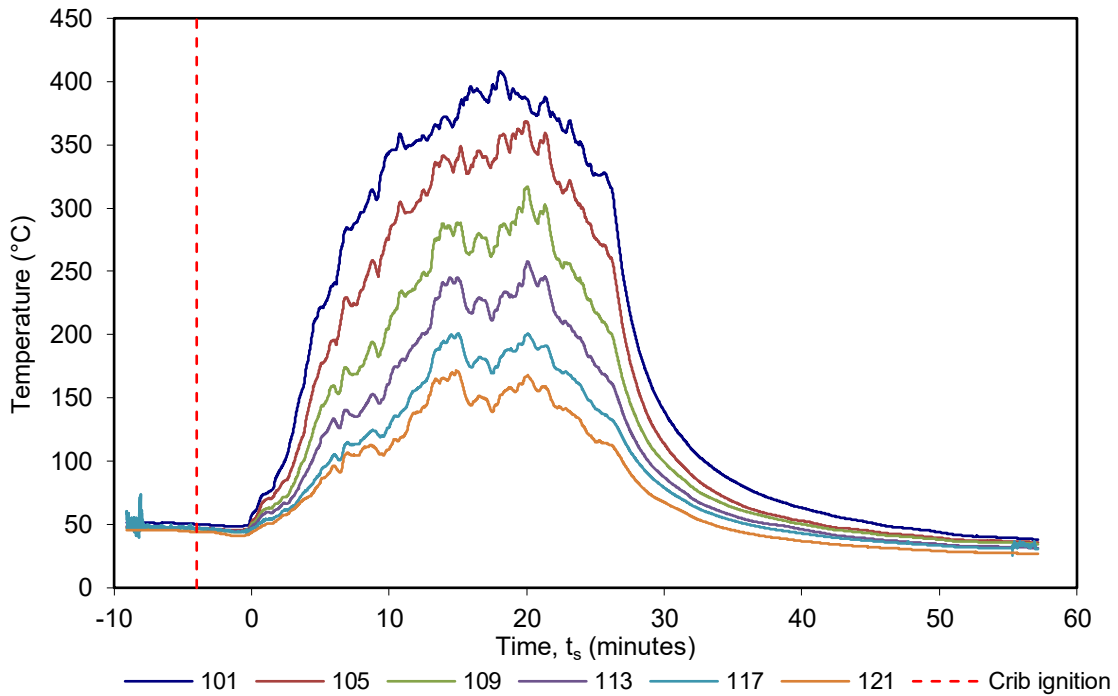
**Figure 13 Plate thermometers at 500 mm vertical centres, left-edge of chamber – temperature vs time**

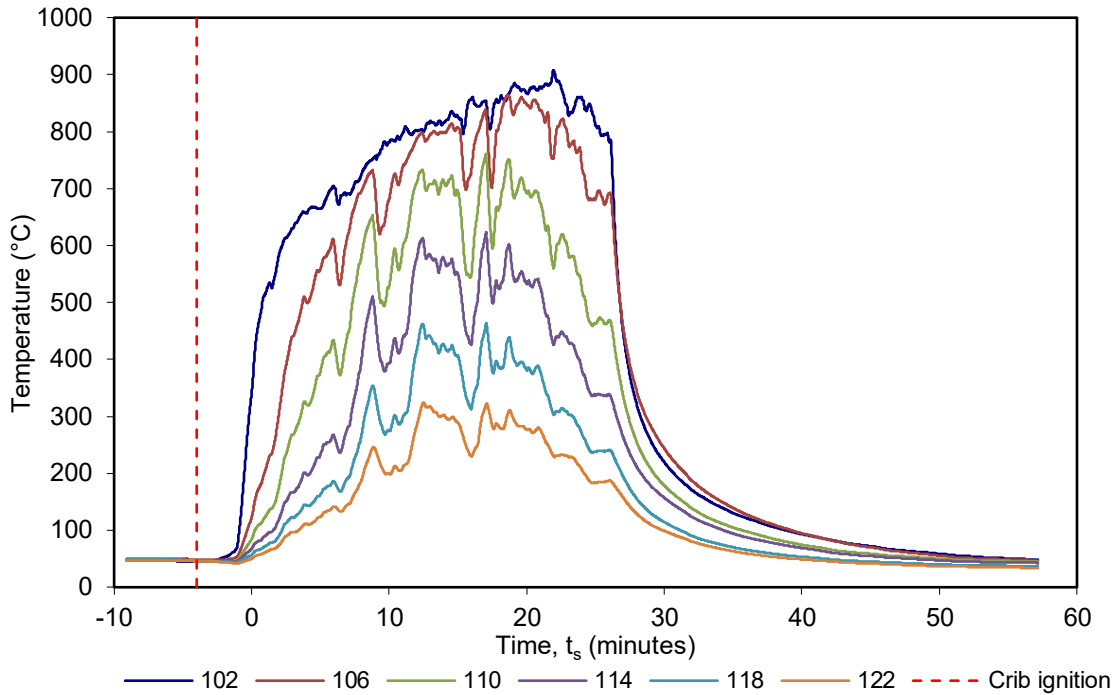
**Figure 14 Plate thermometers at 500 mm vertical centres, centre of chamber – temperature vs time**

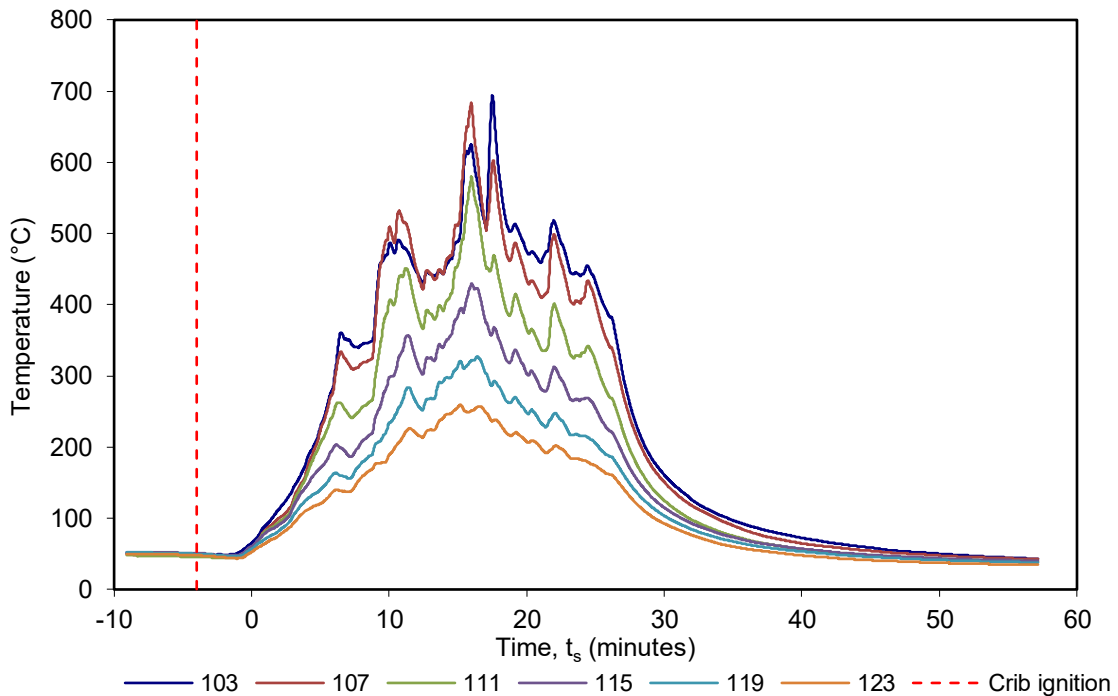
**Figure 15 Plate thermometers at 500 mm vertical centres, right-edge of chamber – temperature vs time**

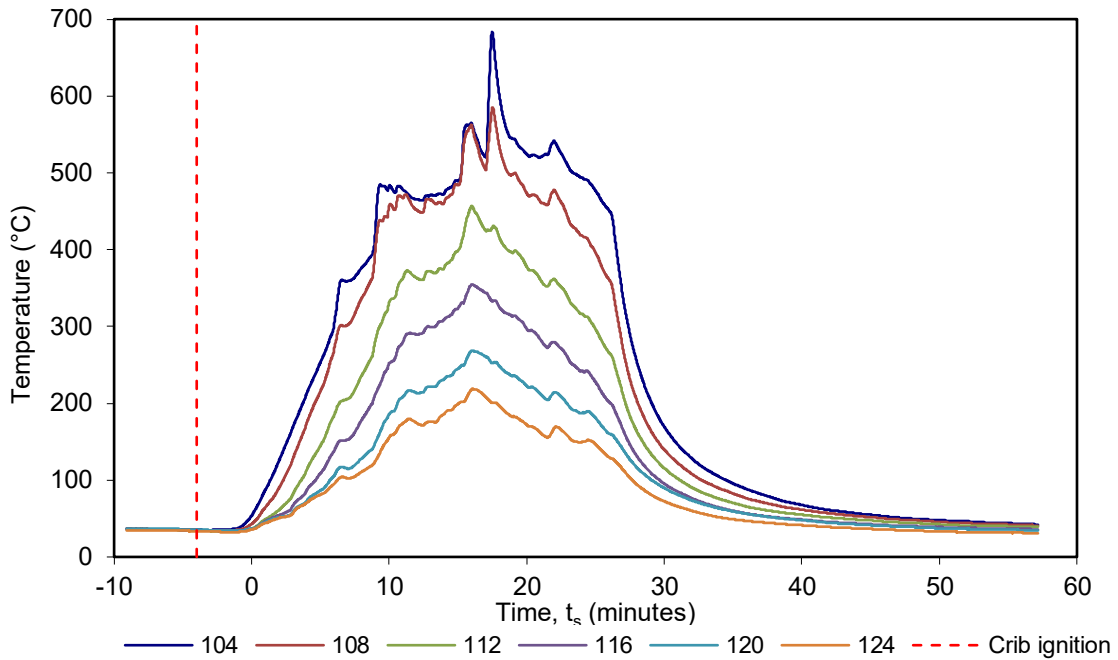
**Figure 16** Plate thermometers at 500 mm vertical centres, mid-width of wing wall – temperature vs time

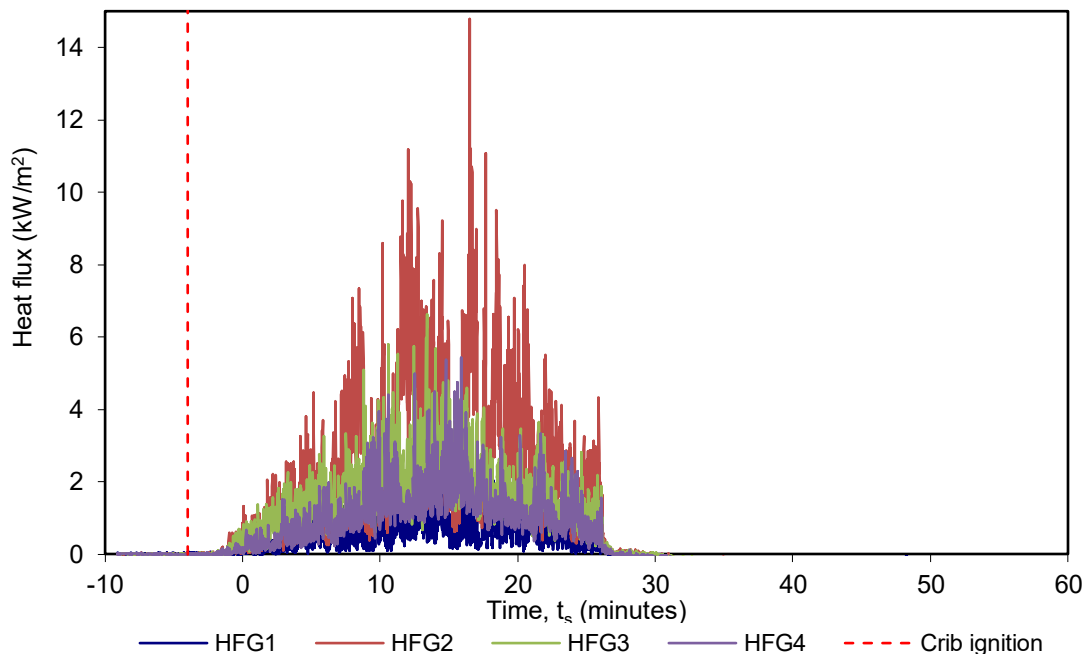
**Figure 17** Exposed face incident heat flux – heat flux vs time

**Note:** The heat flux measurements were located 5625 mm above the chamber opening.

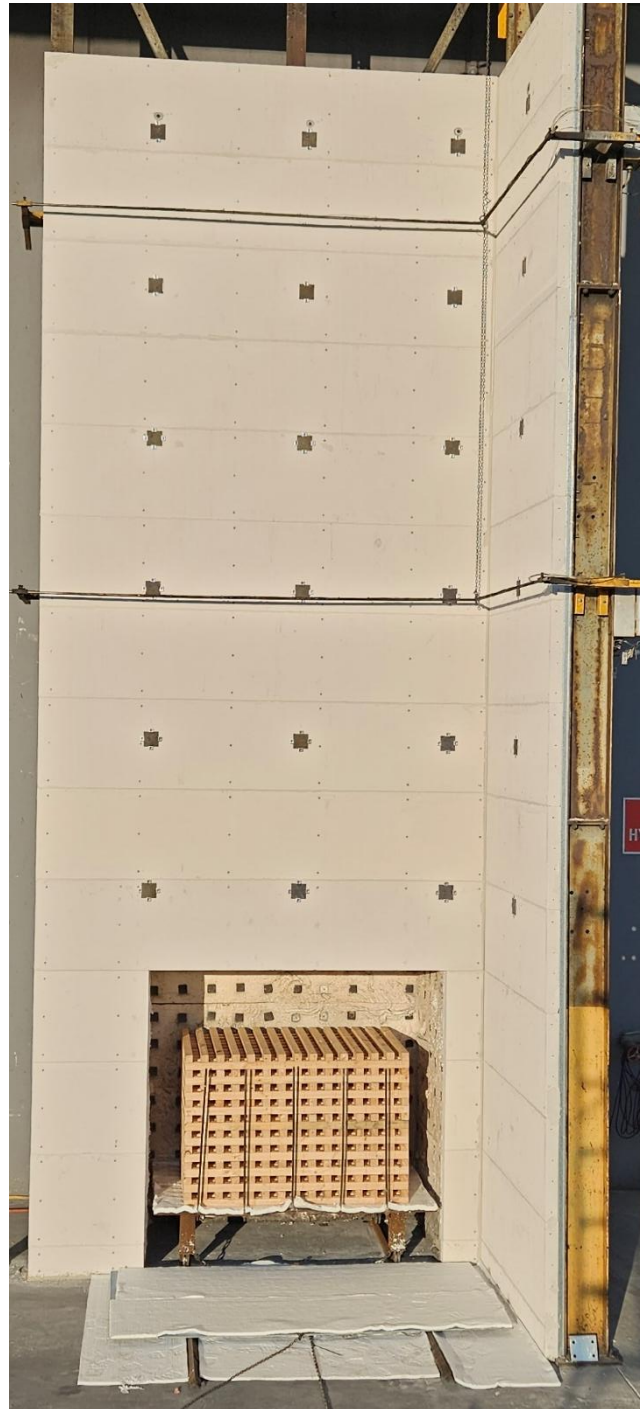
**Figure 18** The external cladding system before the start of the test – main wall

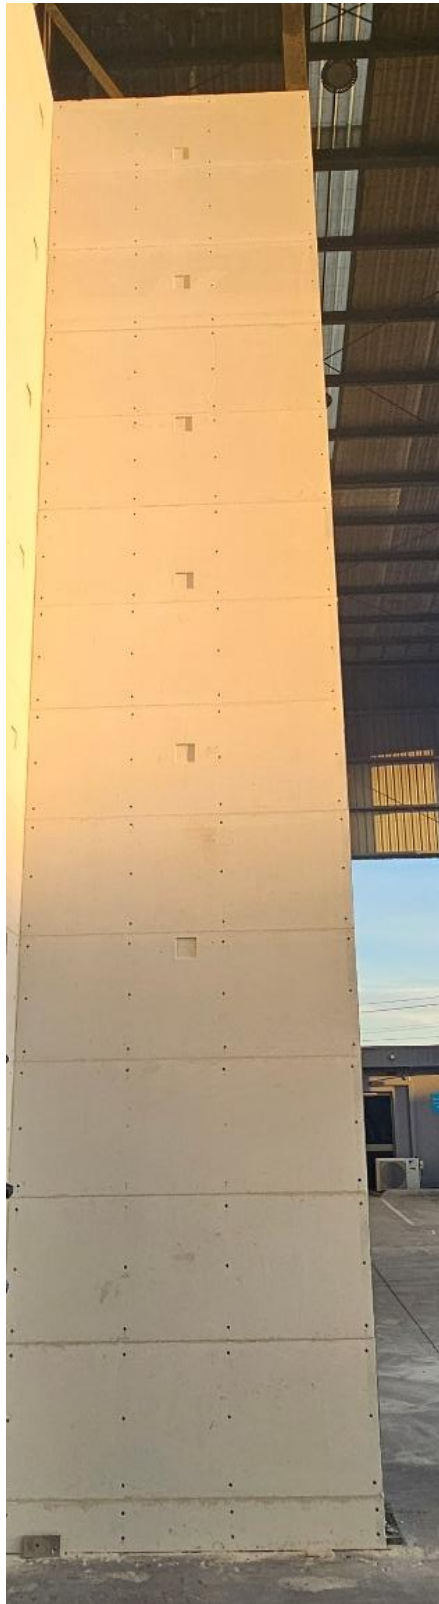
**Figure 19** The external cladding system before the start of the test – wing wall

Note: Picture taken prior instrumentation installation.

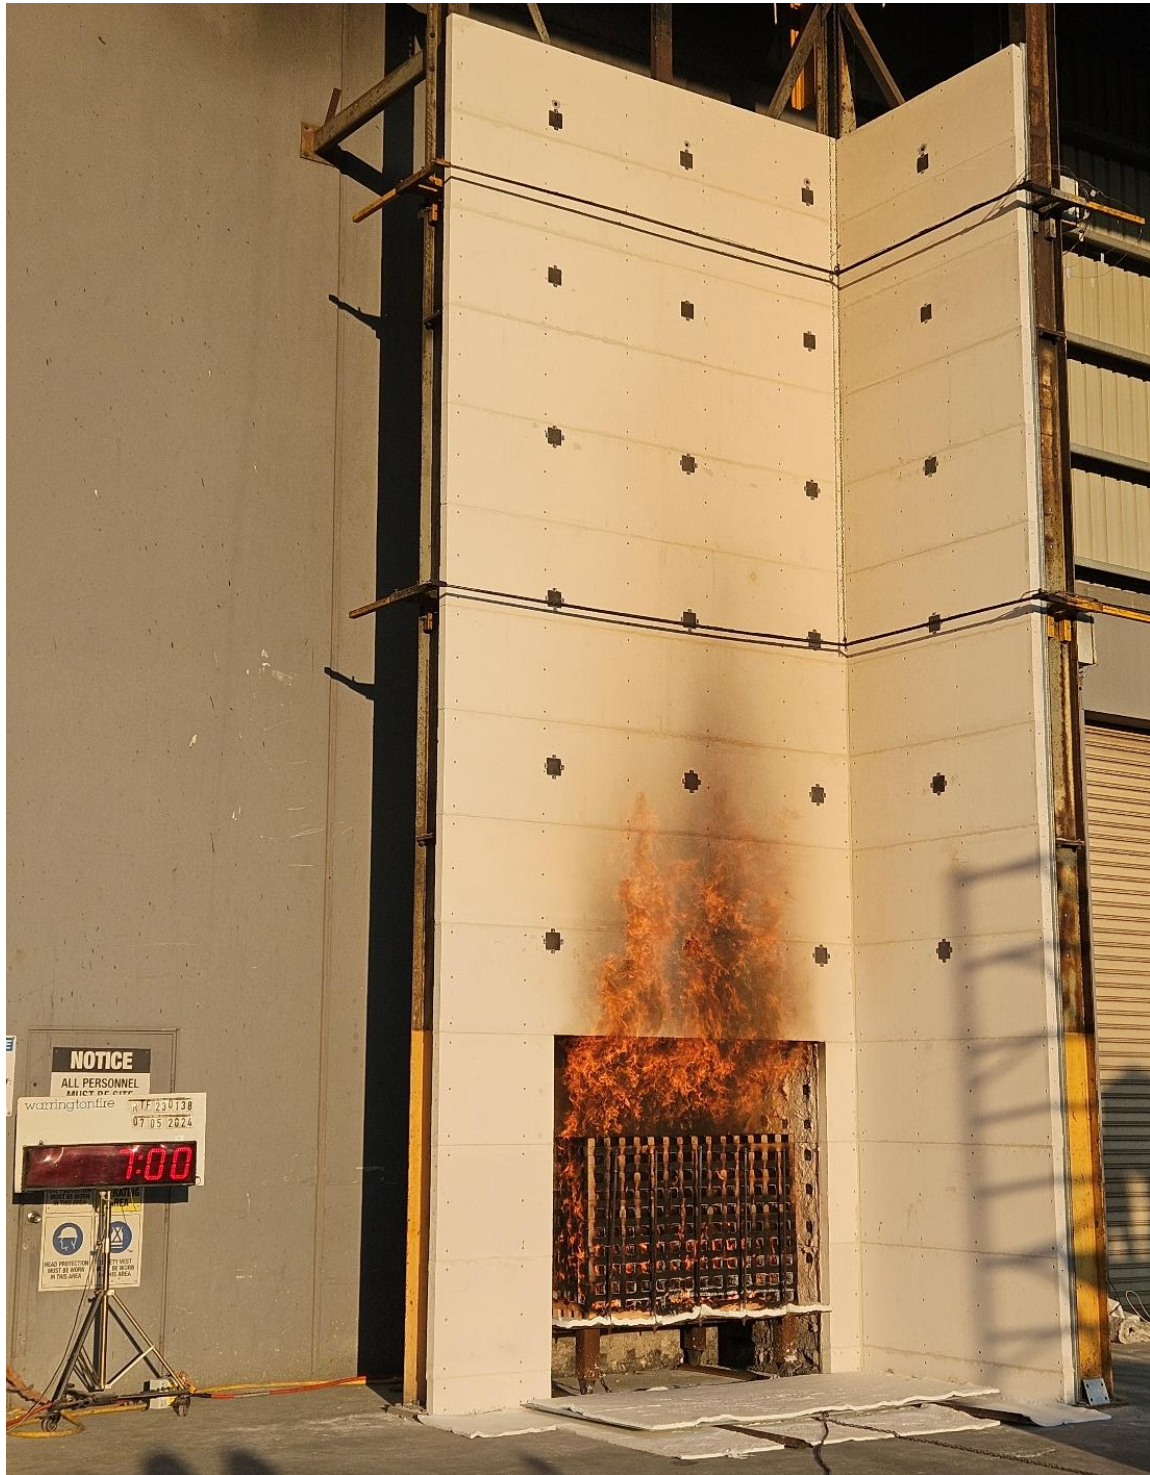
**Figure 20 The external wall system during the test – 7 minutes after crib ignition**

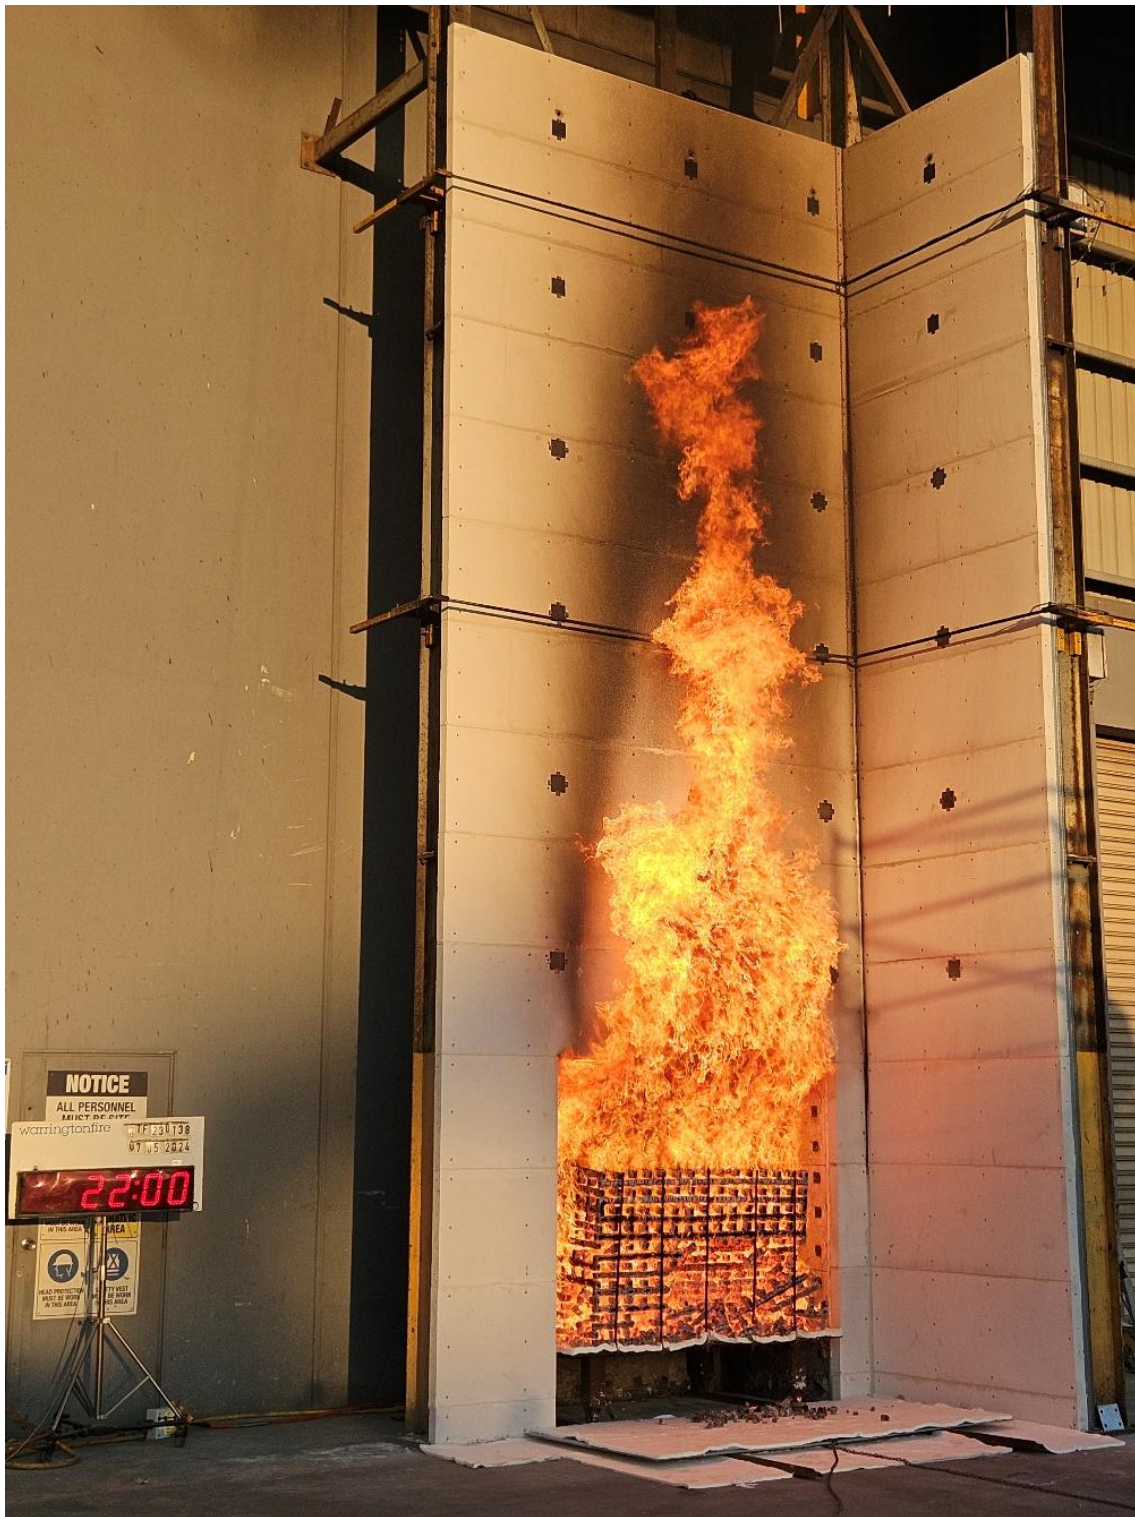
**Figure 21** The external wall system during the test – 22 minutes after crib ignition

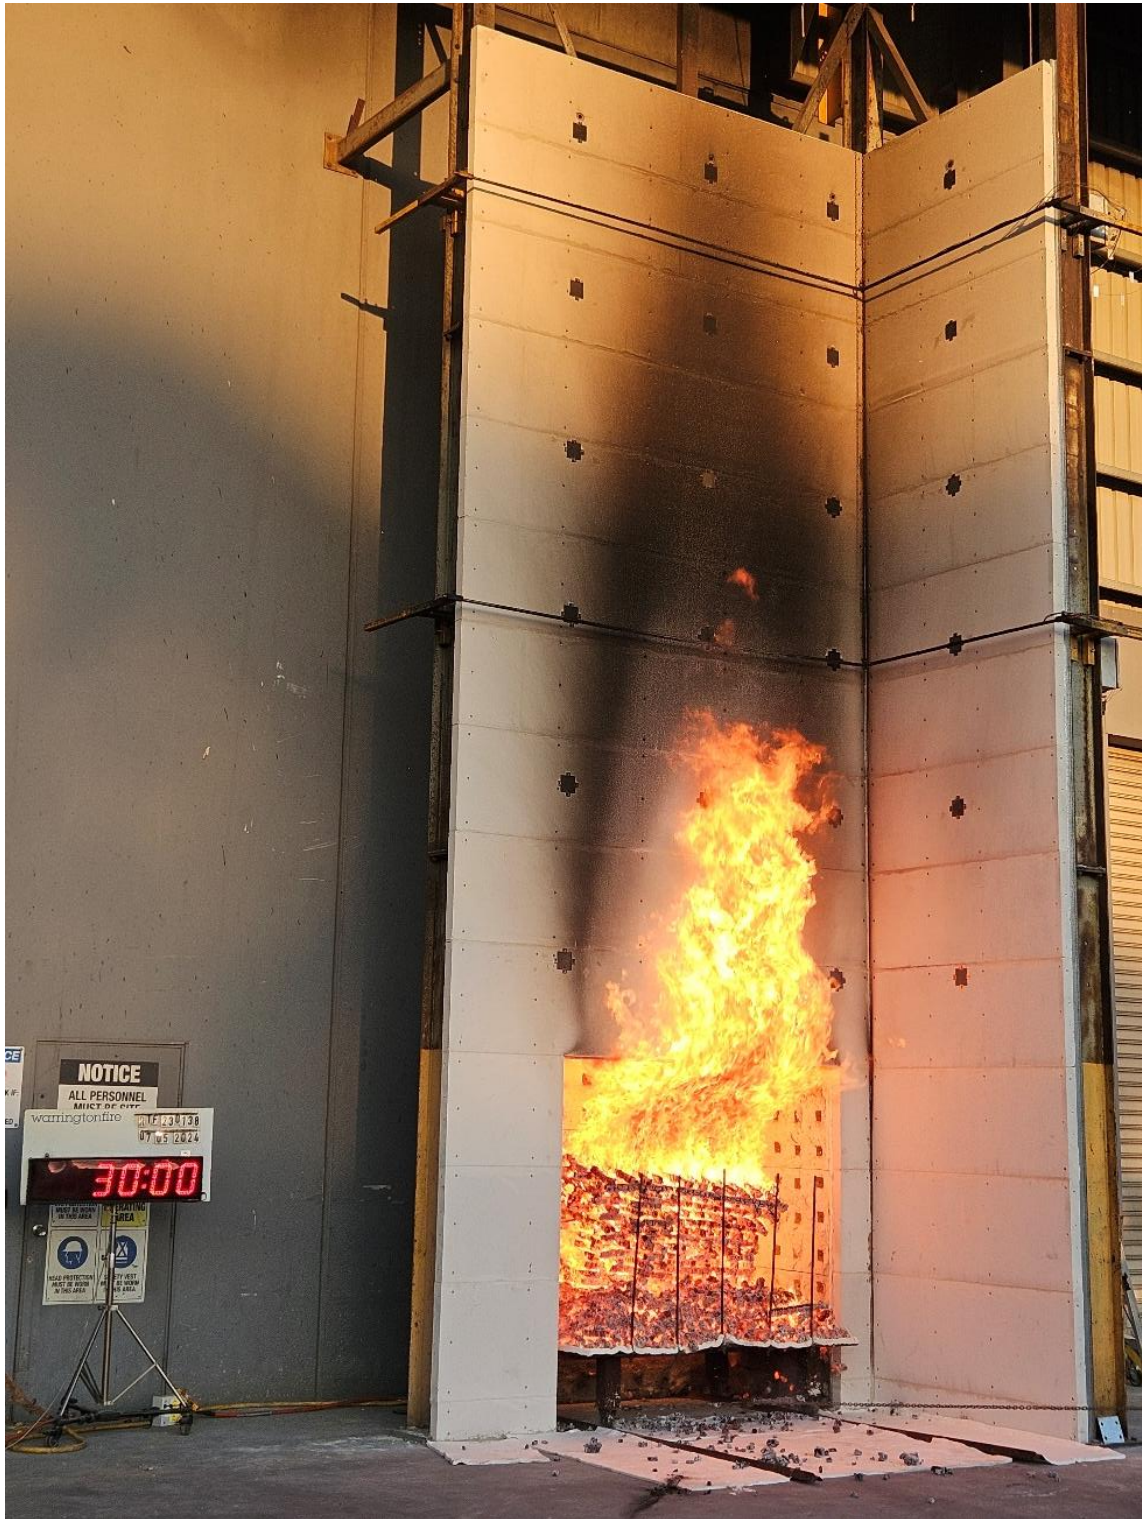
**Figure 22** The external wall system during the test – specimen during removal of the crib, 30 minutes after ignition of crib

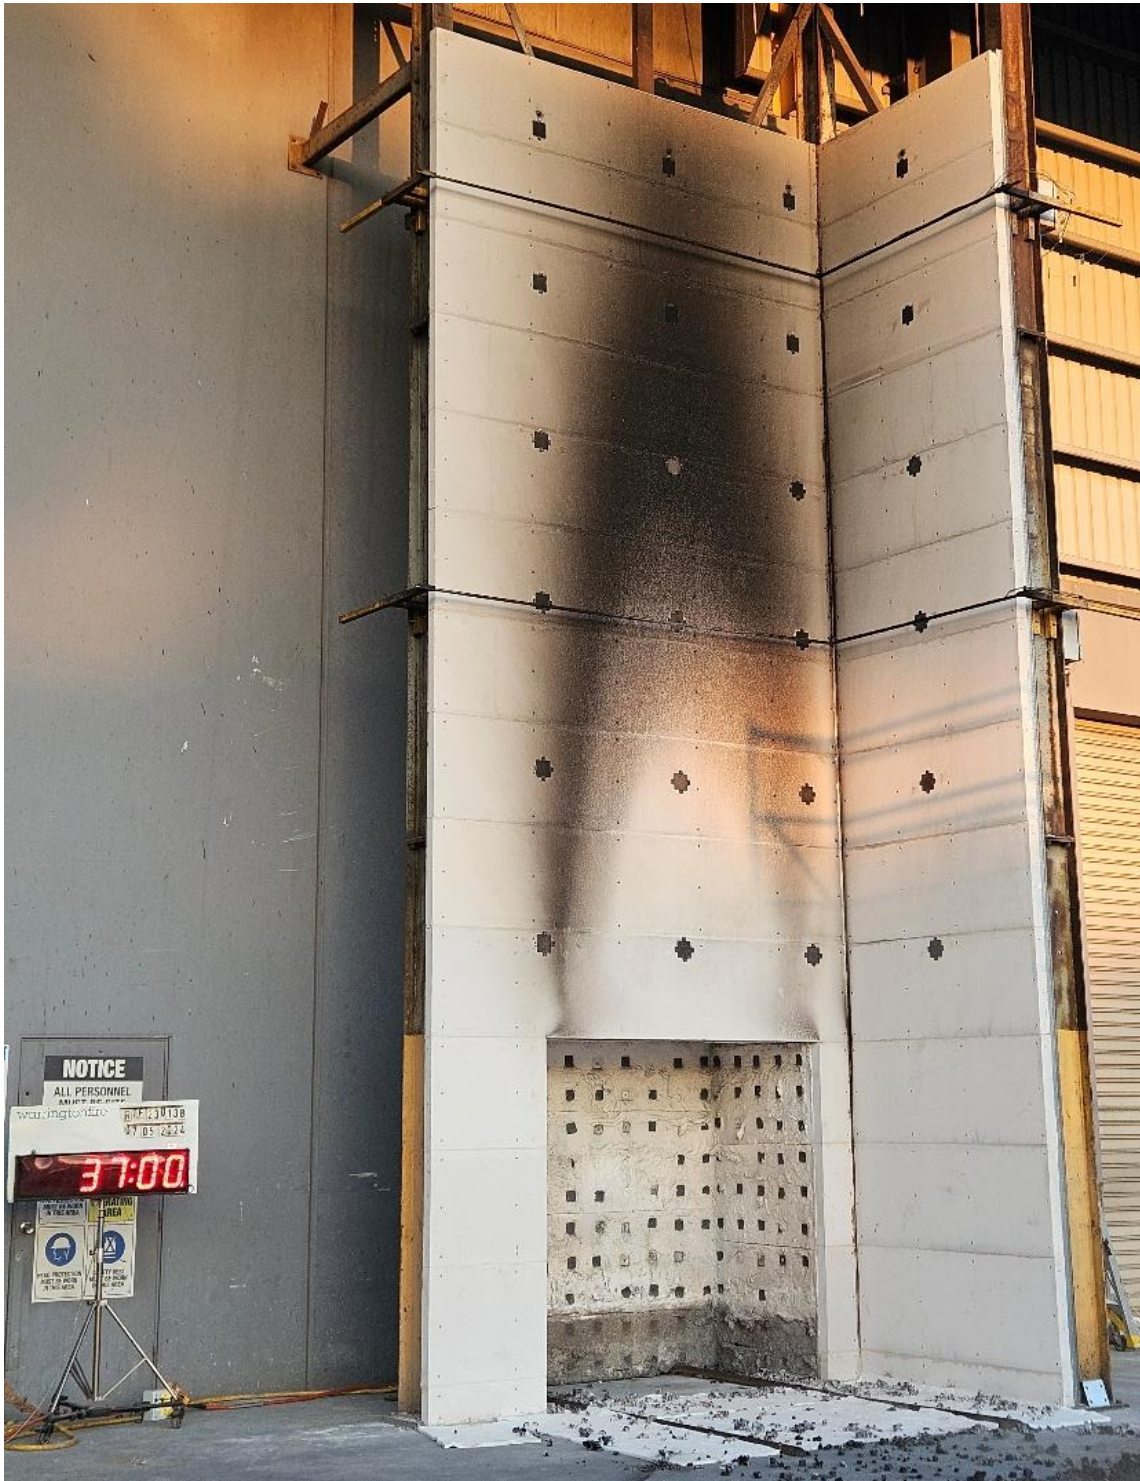
**Figure 23** The external wall system during the test – 37 minutes after crib ignition
