# Reaction to fire test report

Test standard: BS 8414-2:2015

Product: [REDACTED] wall system

Job number: RTF230138

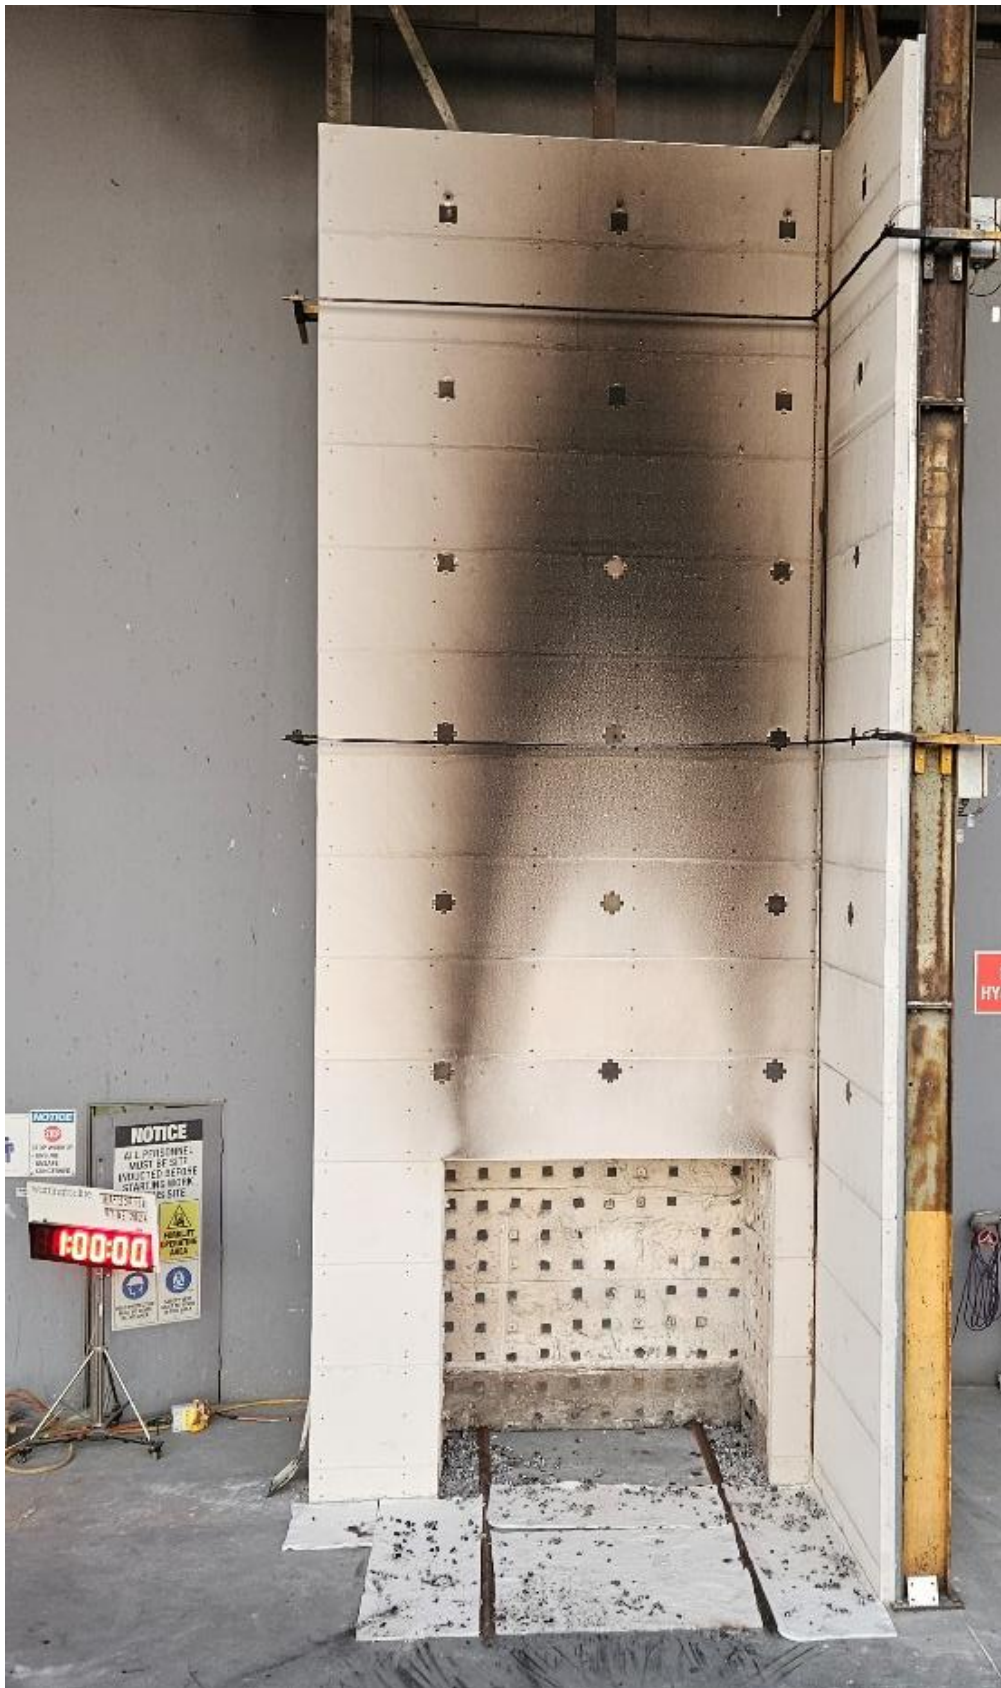
**Figure 24 The external wall system on completion of the test – main wall**

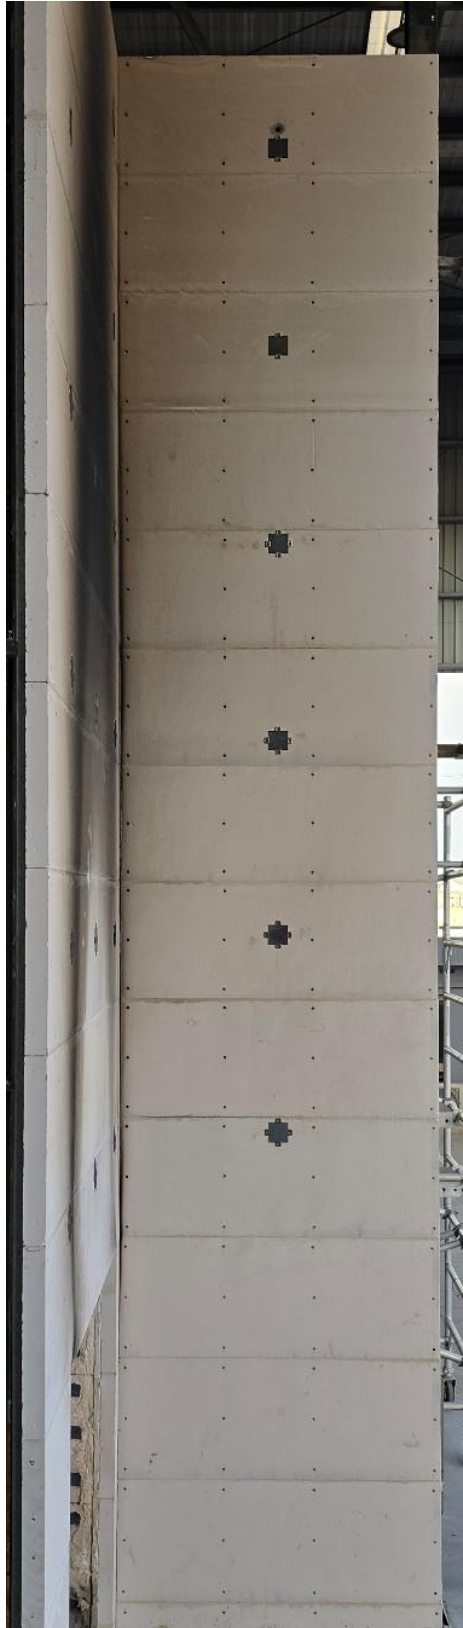
**Figure 25** The external wall system on completion of the test – wing wall

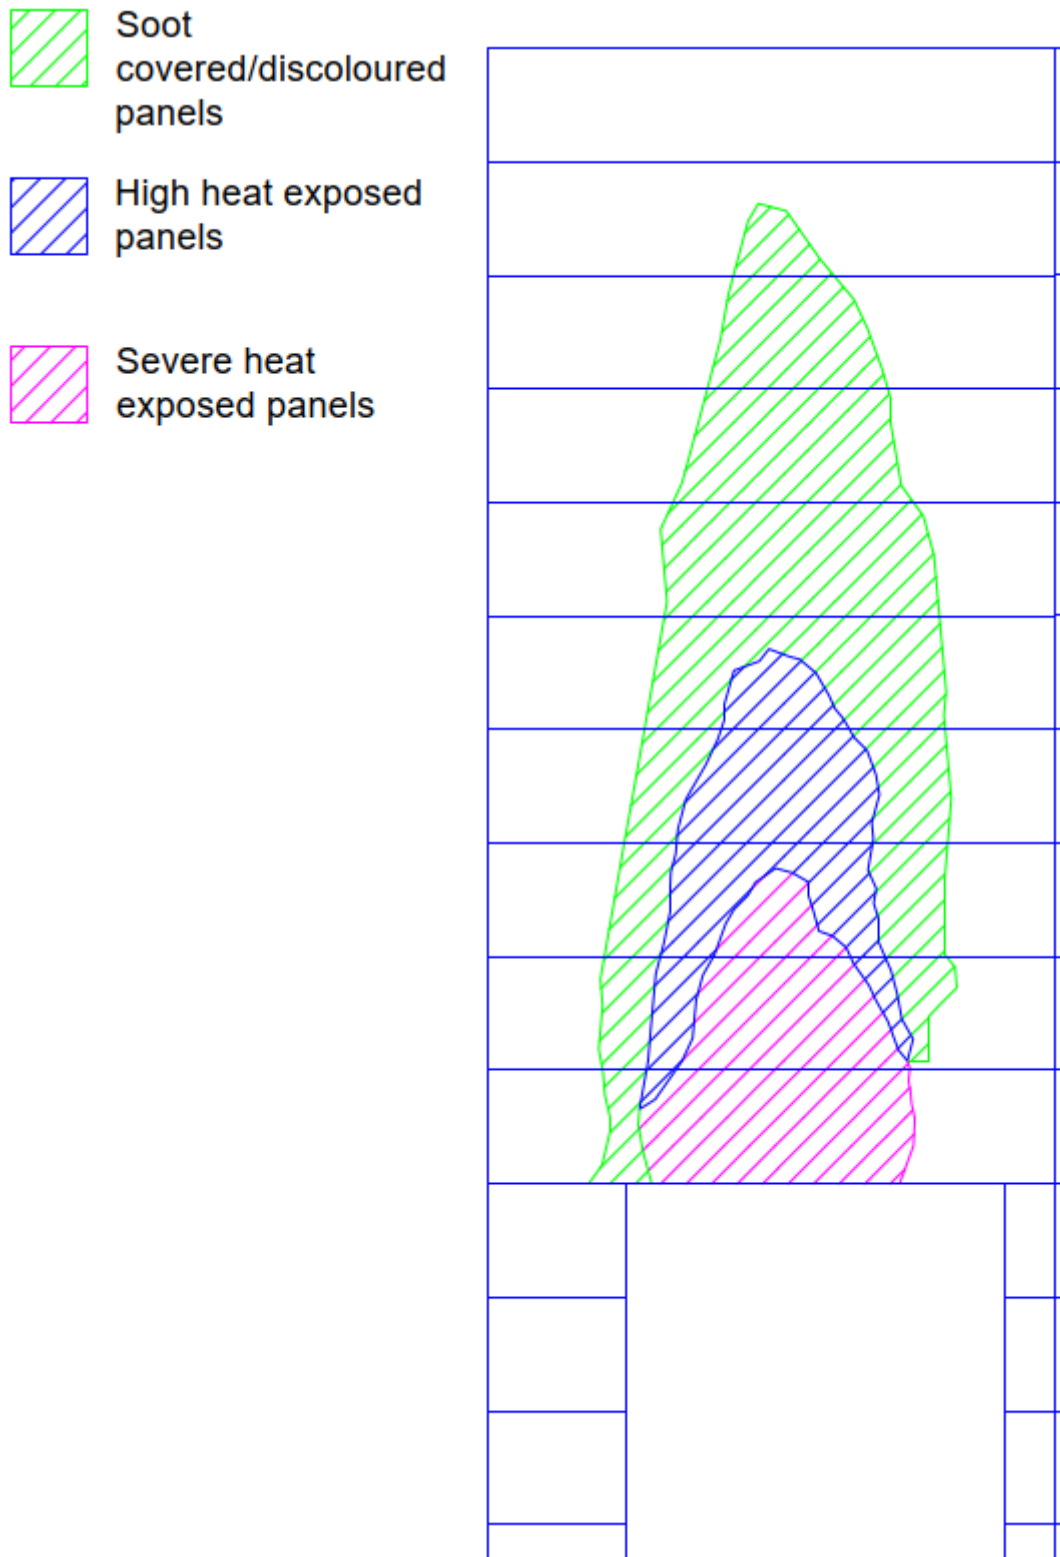
**Figure 26 The post-test external wall system – exposed side**

The damaged area of the cladding system is described as follows;

See Figure 26 for more details.
