Reaction to fire test report

Test standard: Ad-hoc test based on ISO 13785-1:2002

System: Rendered EPS external façade cladding system, 2400 mm wide

Job number: RTF240046

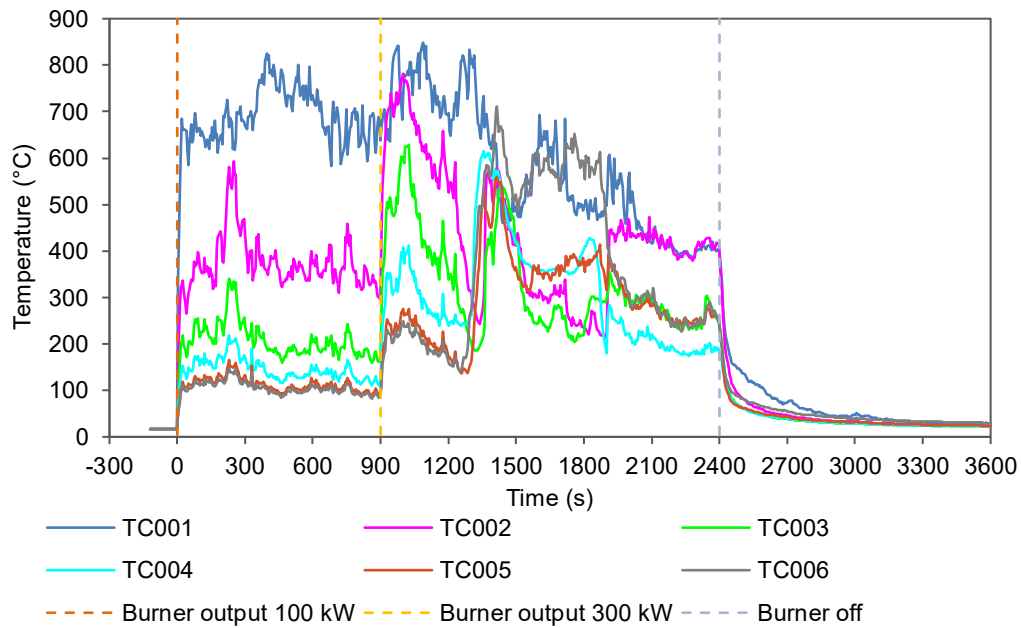
Figure 1 50 mm from the exposed face – Temperature vs time

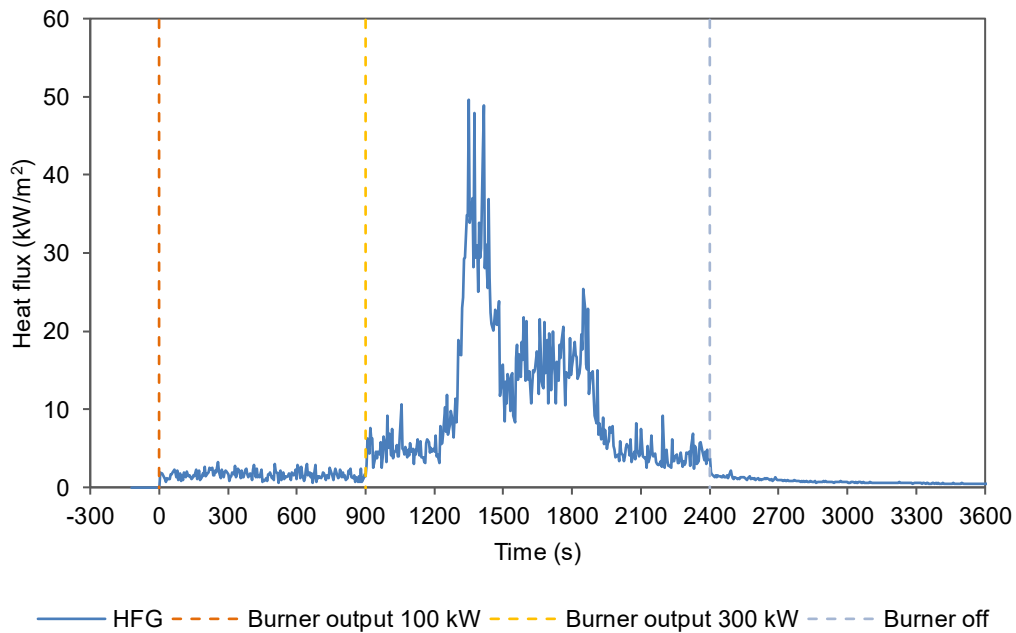
Figure 4 Heat flux vs time

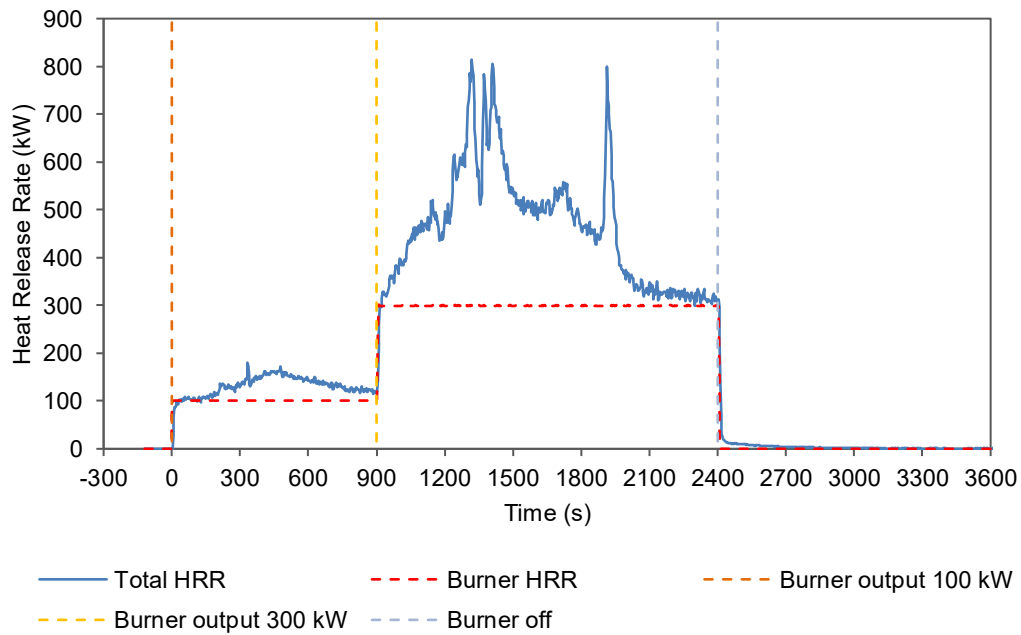
Figure 6 Heat release rate (HRR) of specimen and burner vs time

Test procedure	<ul style="list-style-type: none"> At least 2 minutes of baseline data was collected prior to burner ignition. Temperature and heat flux data was collected at 5 s intervals, while the combustion products sampling data was collected at 3 s intervals. The heat output from the burner was held at 100 kW for 15 minutes, then 300 kW for the following 25 minutes. The burner was then turned off and data was recorded for the following 20 minutes.

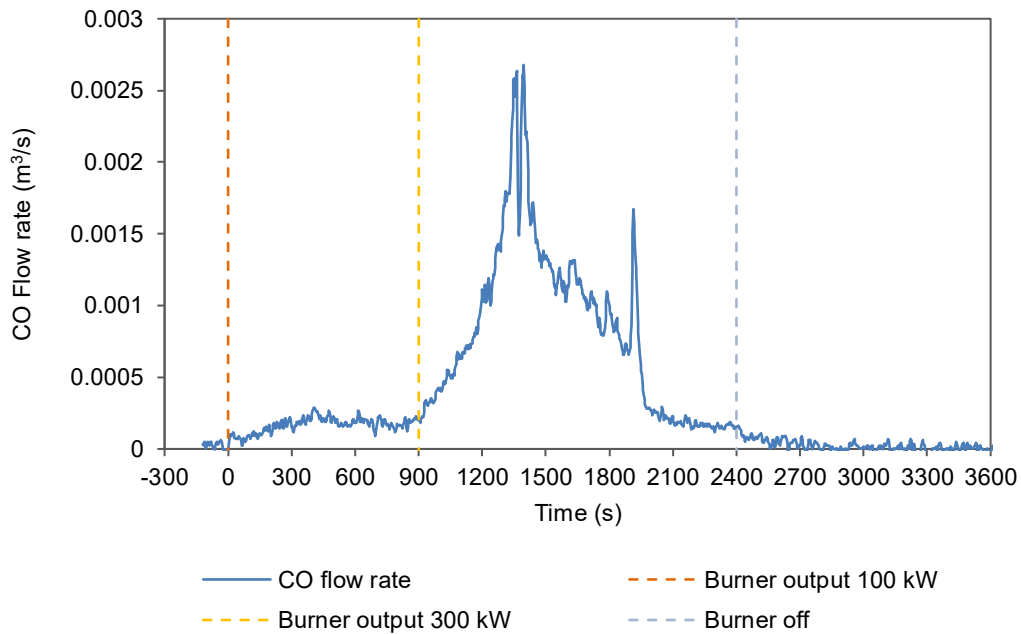
Figure 7 Production of carbon monoxide vs time, at reference temperature and pressure

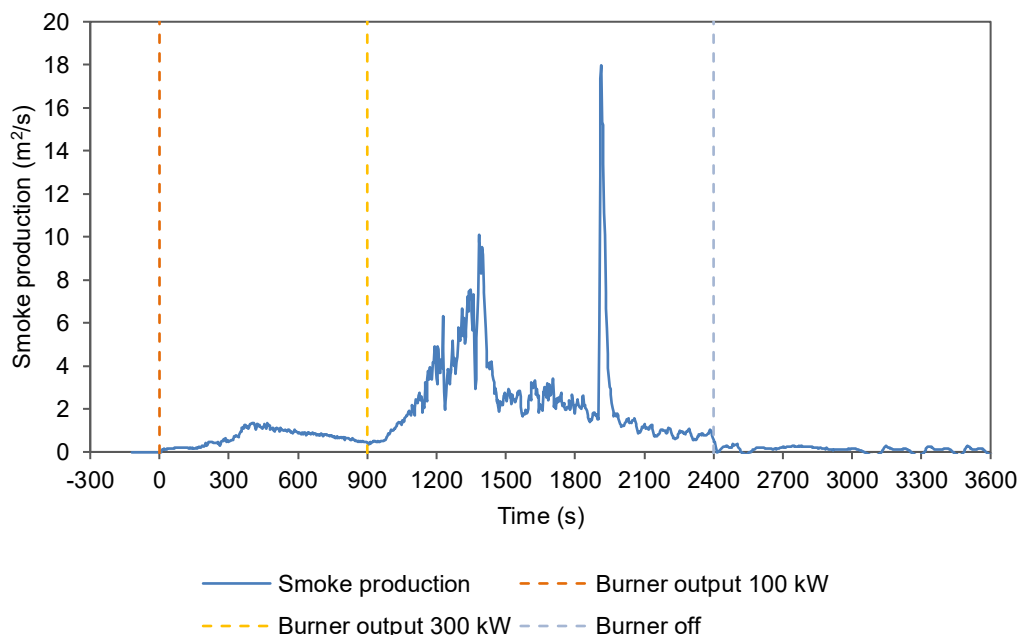
Figure 9 Production of light obscuring smoke vs time, at reference temperature and pressure

Item	Detail
	<ul style="list-style-type: none"> Smoke obscuration measurements were made using a helium-neon laser smoke photometer, as outlined in Annex H of ISO 9705-1:2016. The temperature of the exhaust stream near the light beam was measured using a type K MIMS thermocouple. An exhaust sampling probe sampled the combustion products which were then analysed by a gas purity analyser. The oxygen concentration during the test was determined by a paramagnetic oxygen sensor and the carbon monoxide and carbon dioxide concentrations were determined using an infrared sensor. The horizontal wind speed will be measured using a hot wire anemometer at a horizontal distance of 500 mm away from the centre of the exposed face of the tested specimen. A Fourier Transform Infrared Spectroscopy (FTIR) gas analyser was connected to the exhaust duct, and operated by representatives of the test sponsor to sample the products of combustion during the test.

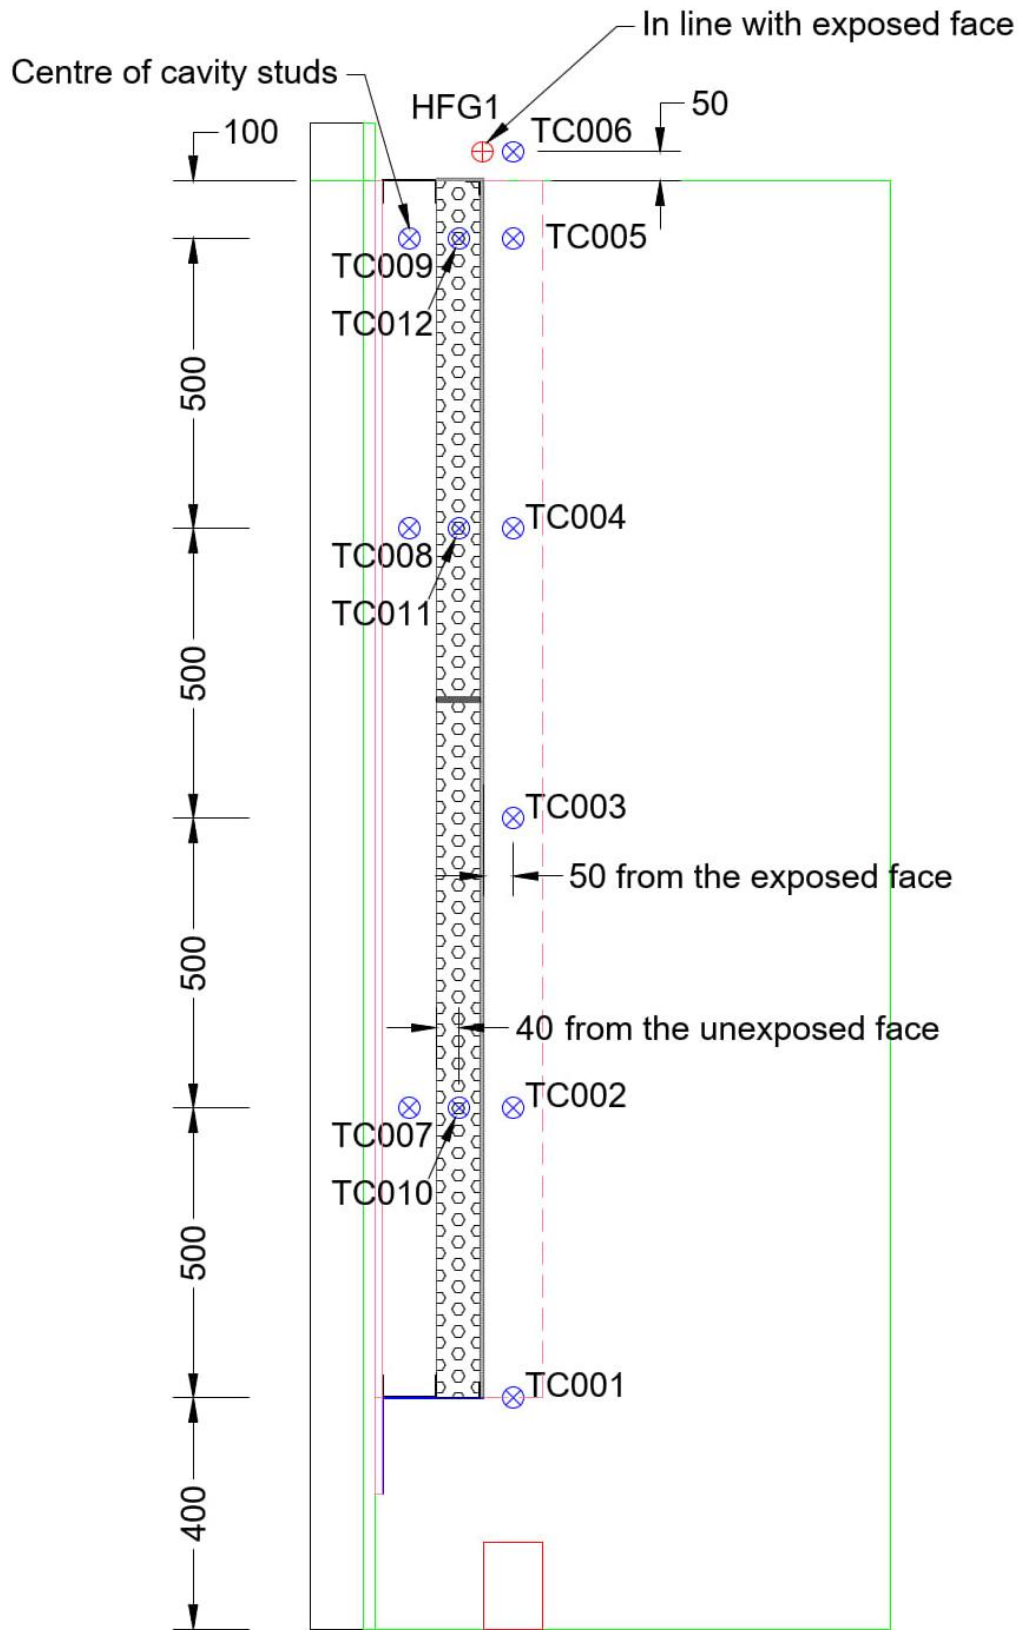
Figure 15 Instrumentation locations – Vertical cross-sectional view

Test duration	60 minutes	
Instrumentation and equipment	<ul style="list-style-type: none"> 6 mineral insulated metal sheathed (MIMS) Type K thermocouples with an overall diameter of 1.5 mm with the measuring junction insulated from the sheath were positioned at various heights, 50 mm in front of the outer face of the test specimen along its vertical centreline. Refer to Figure 14 and Figure 15 for details on positioning. 3 MIMS Type K thermocouples with an overall diameter of 1.5 mm with the measuring junction insulated from the sheath were positioned at various heights at mid-depth of the framing cavity of the test specimen. Refer to Figure 14 and Figure 15 for details on positioning. 3 MIMS Type K thermocouples with an overall diameter of 1.5 mm with the measuring junction insulated from the sheath were positioned at various heights at a depth of 40 mm from the unexposed face of the cladding of the test specimen. Refer to Figure 14 and Figure 15 for details on positioning. The fire source was a propane (95% purity) gas fuelled box burner; 1.2 m wide × 0.1 m deep × 0.15 m tall. The burner was located on the floor in front of the specimen, with the back edge of the burner in line with the exposed face of the specimen. The incident heat flux 50 mm above and in line with the exposed face of the test specimen was measured using a Schmidt-Boelter type heat flux gauge with a range of 0 - 100 kW/m². The products of combustion were collected in an exhaust hood located centrally above the exposed face of the tested specimen. The hood was connected to an exhaust duct 400 mm in diameter, which had instruments inside to measure the conditions and properties of the combustion products during the test. The hood had specifications based on those given in AS ISO 9705:2003 (R2016), with the only differences being that all four sides had 1 m steel sheet extensions, and there was no fire test room. The volume flow rate was determined using a bidirectional pressure probe attached to a differential pressure transmitter together with a type K MIMS thermocouple positioned near the probe.

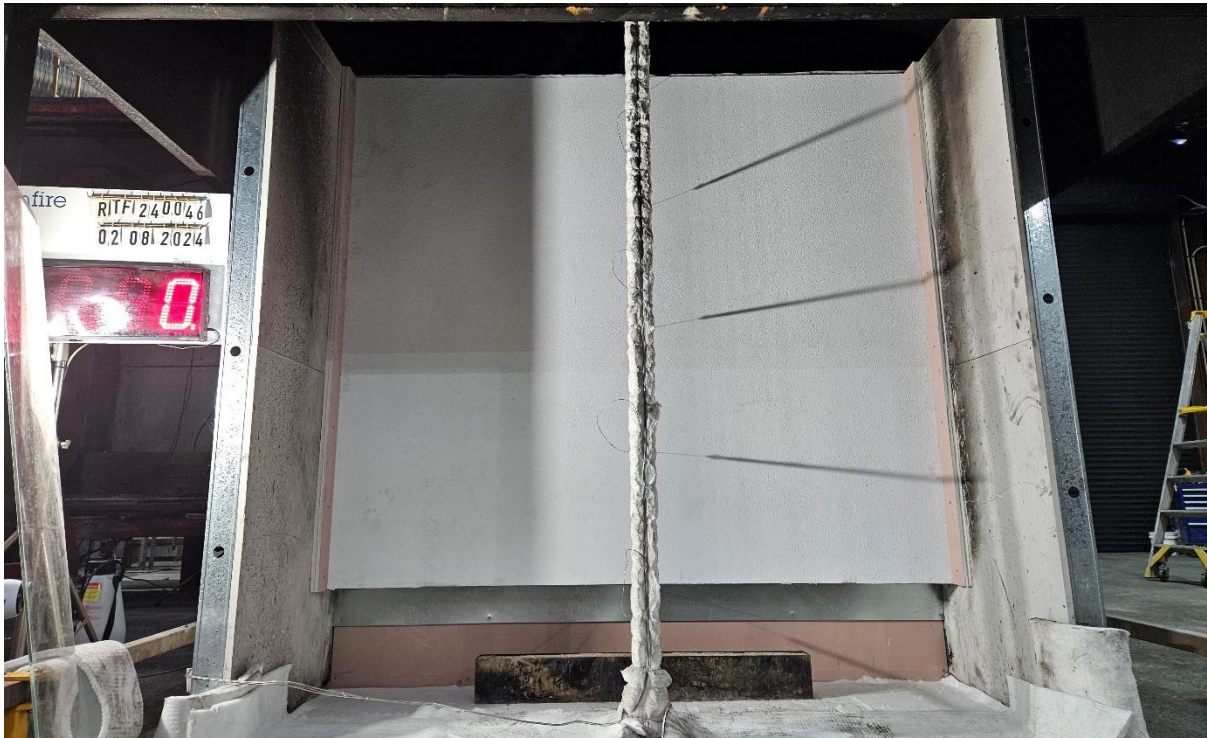
Figure 16 The specimen before the reaction to fire test – exposed side

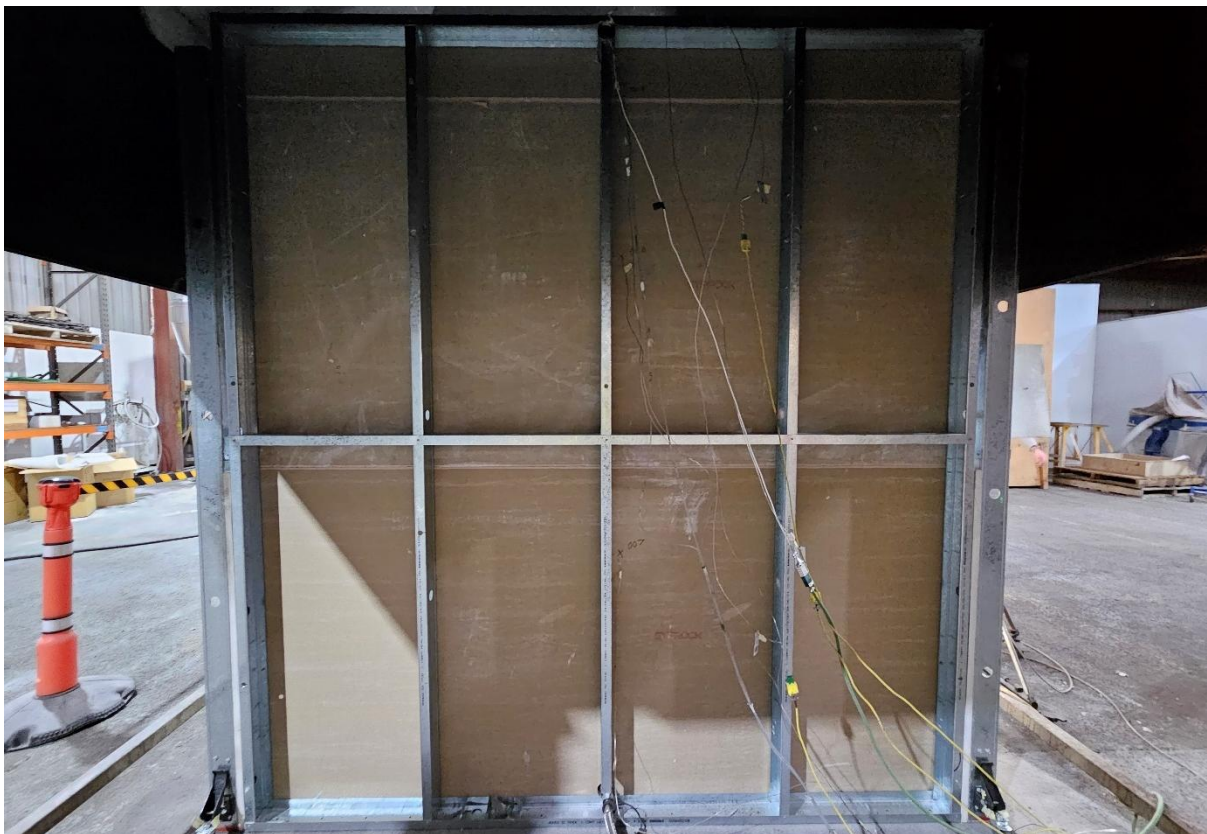
Figure 17 The specimen before the reaction to fire test – unexposed side

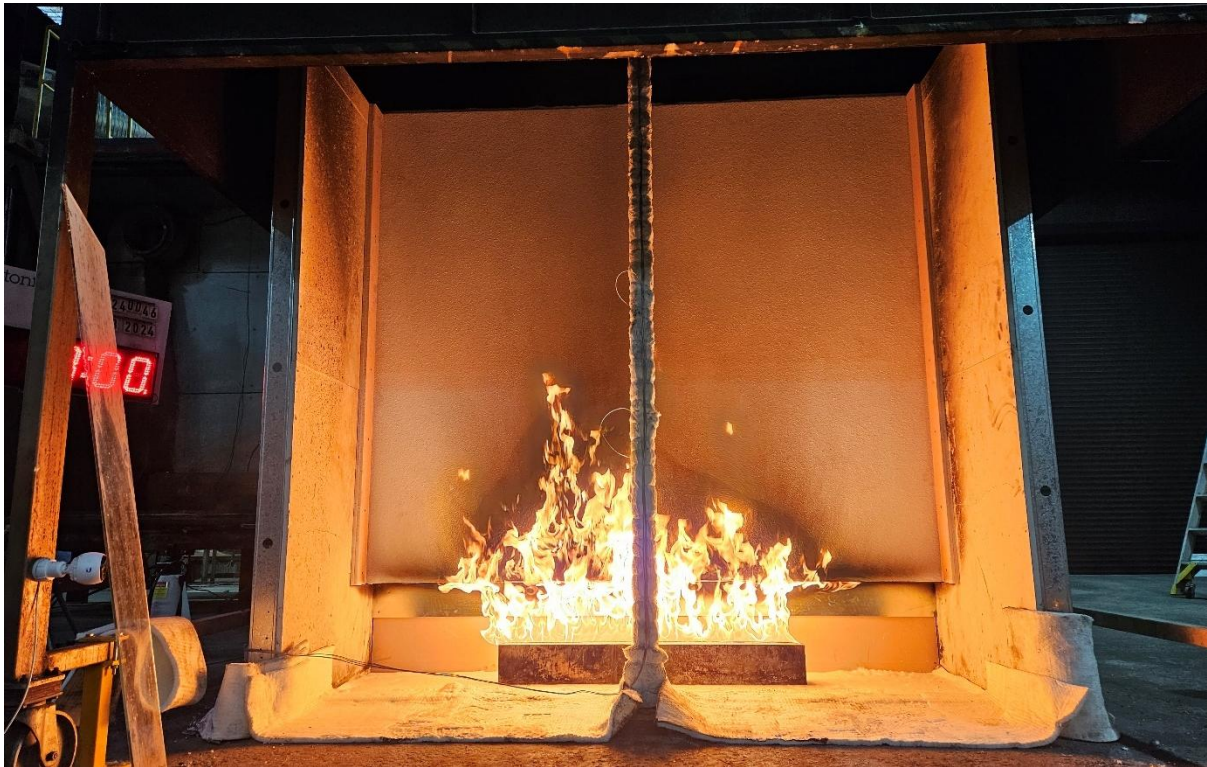
Figure 18 The specimen 3 minutes into the test (burner output at 100 kW)

Time		Observation
Min	Sec	
-2	00	Data collection started.
0	00	The reaction to fire test was started with the burner ignited with a heat output set at 100 kW.
0	43	The steel flashing below the specimen was becoming deformed.
6	27	Molten material dripped from the specimen onto and around the burner.
7	34	The bottom portion of the specimen was deforming.
15	00	The heat output of the burner was increased to 300 kW.
15	11	A loud cracking sound came from the specimen.
16	05	Smoke was emitting from the top of the specimen.
17	51	The top portion of the specimen was intermittently flaming, independent of the burner.
20	15	The top of the specimen was flaming.
22	37	The rendered face of the specimen fell, resting on the burner and thermocouple tree.
31	38	The rendered face of the specimen crumbled and fell onto the burner.
40	00	The burner was turned off.
40	41	The debris on the burner were flaming.
59	38	All flaming had stopped.

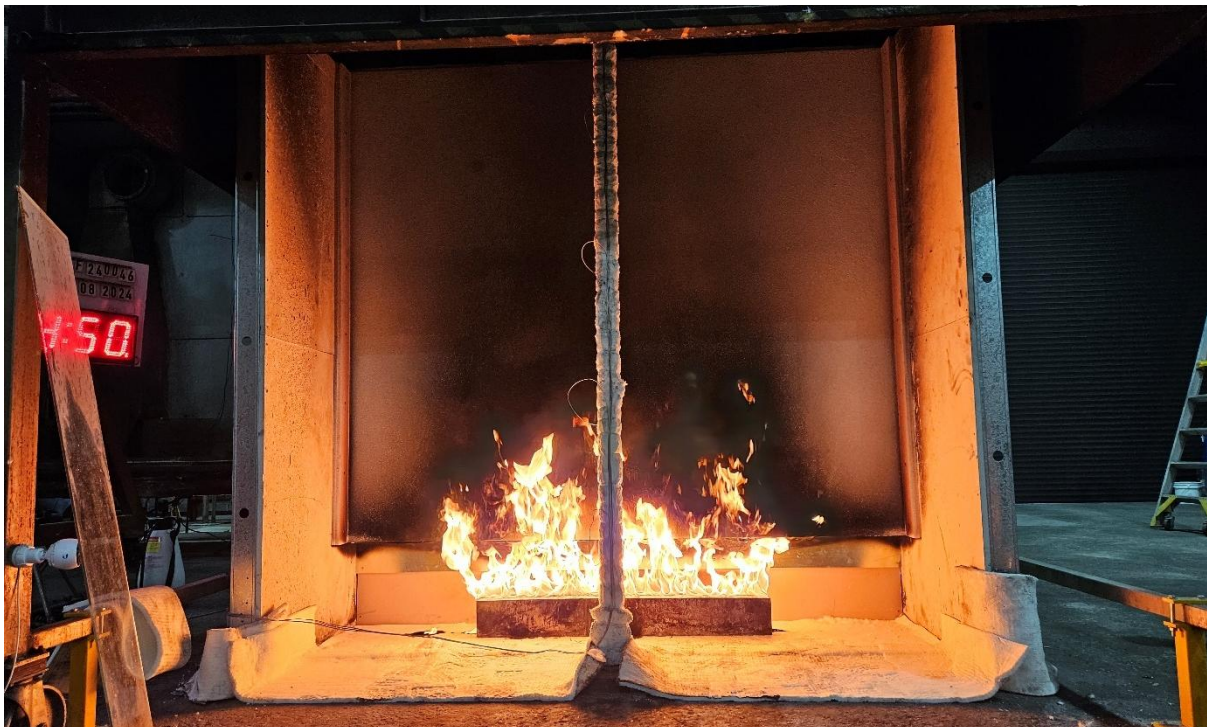
Figure 19 The specimen 14 minutes 50 seconds into the test (burner output at 100 kW)

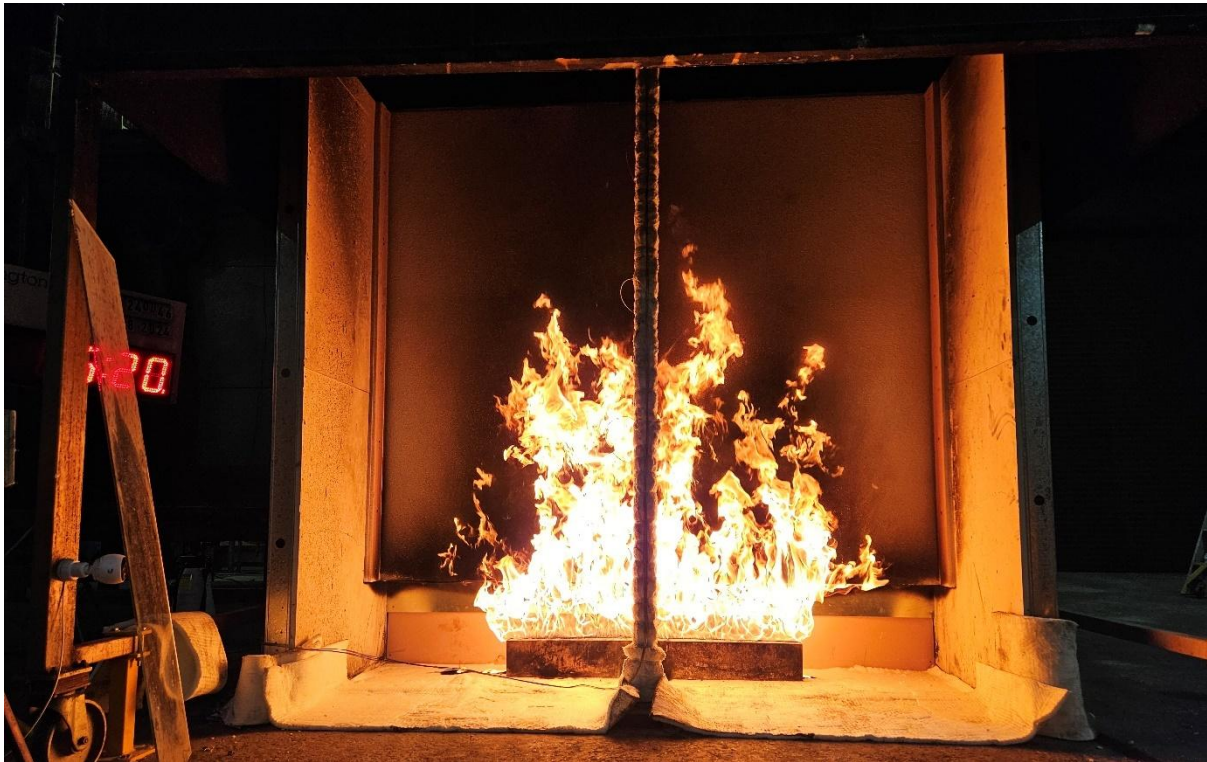
Figure 20 The specimen 15 minutes 20 seconds into the test (burner output at 300 kW)

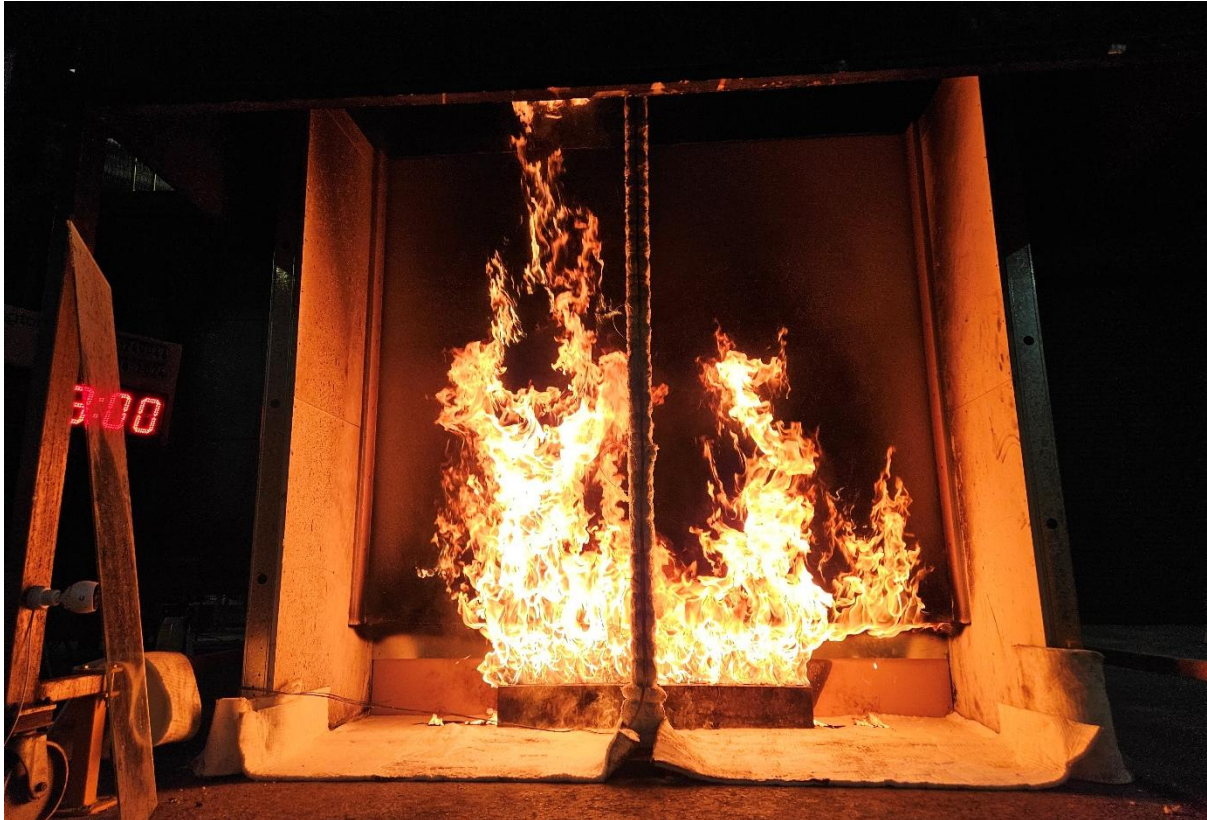
Figure 21 The specimen 18 minutes into the test (burner output at 300 kW)

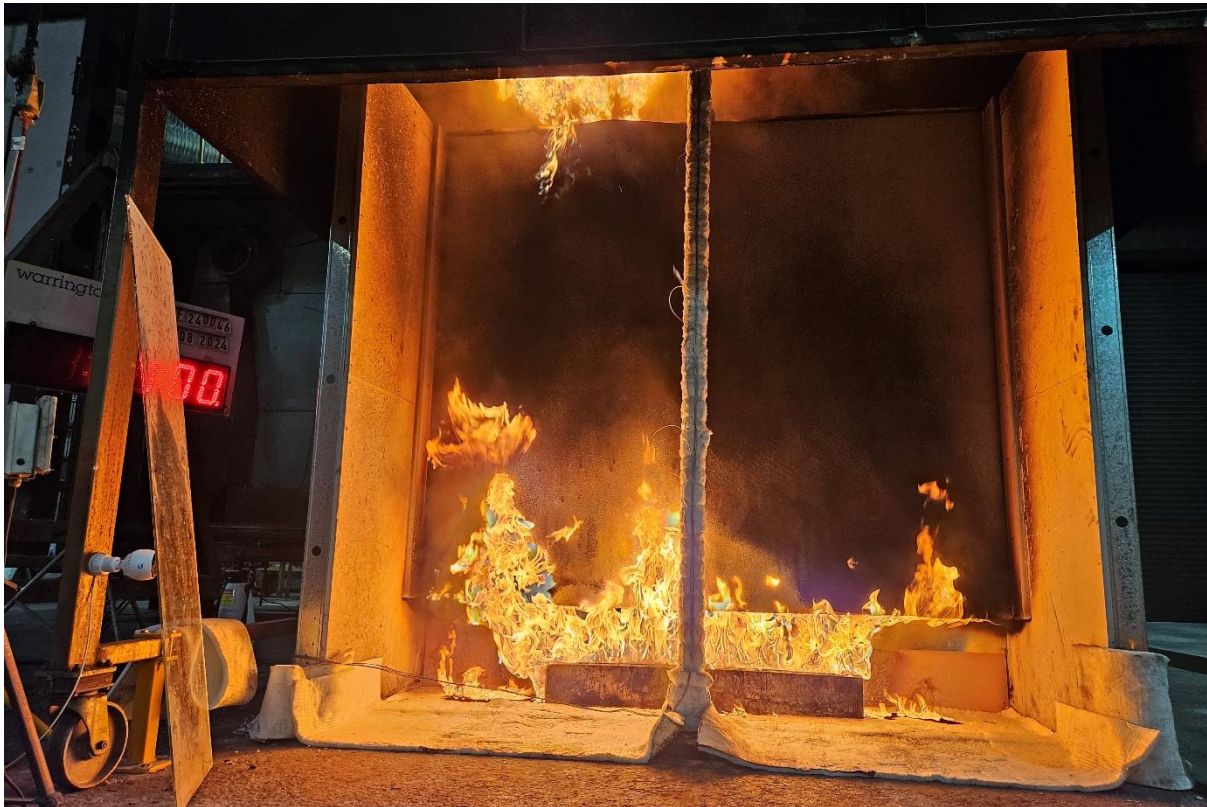
Figure 22 The specimen 21 minutes into the test (burner output at 300 kW)

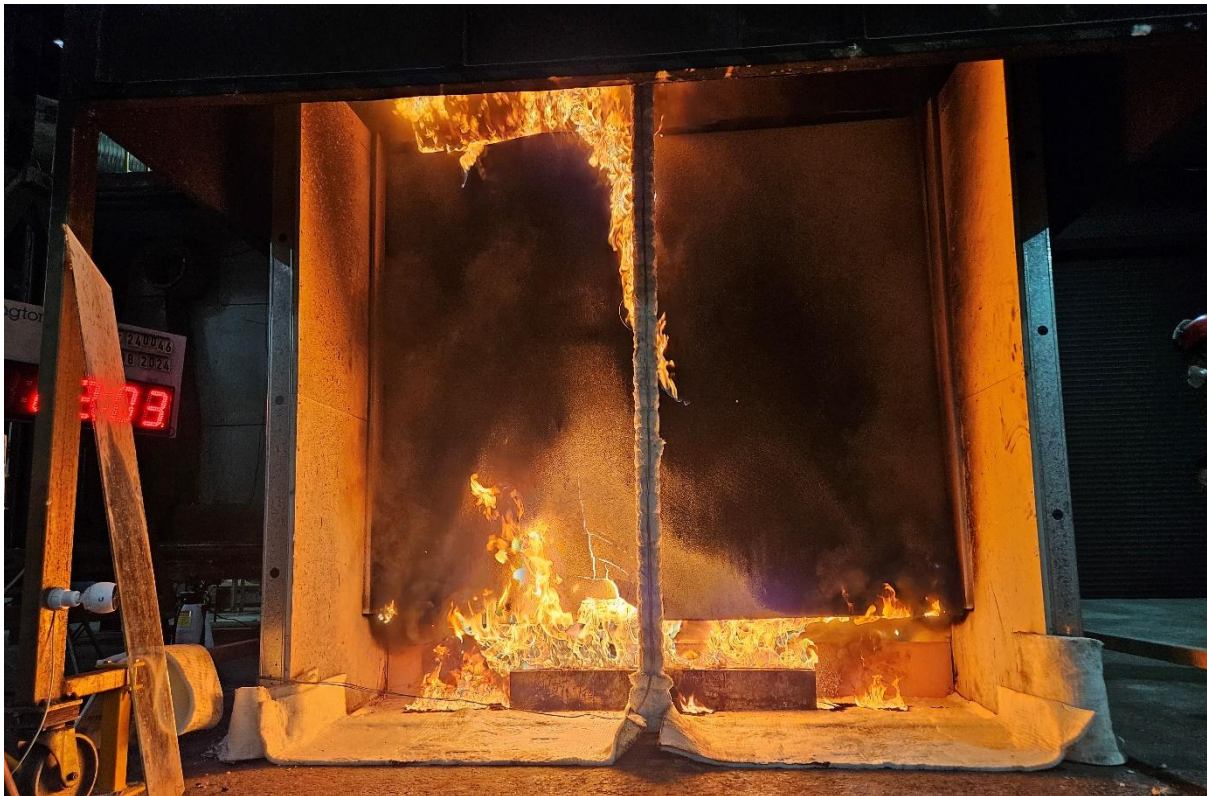
Figure 23 The specimen 22 minutes 3 seconds into the test (burner output at 300 kW)

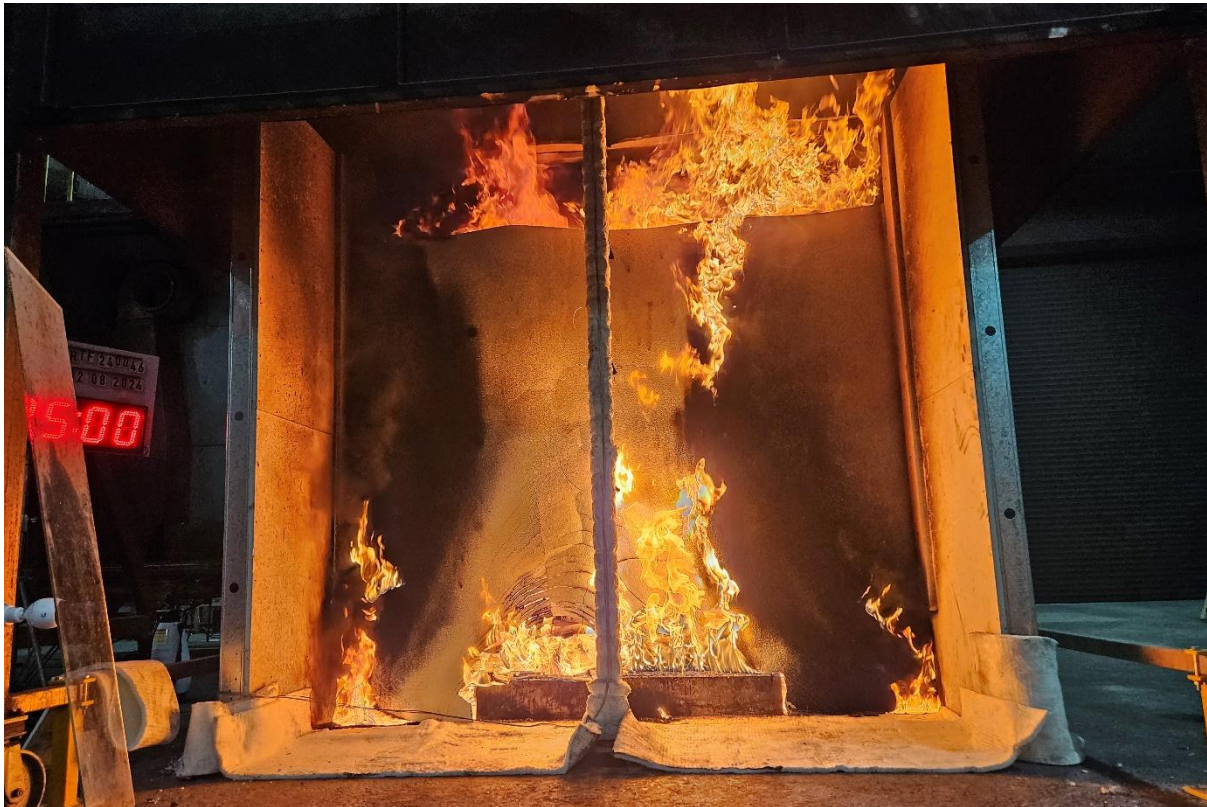
Figure 24 The specimen 25 minutes into the test (burner output at 300 kW)

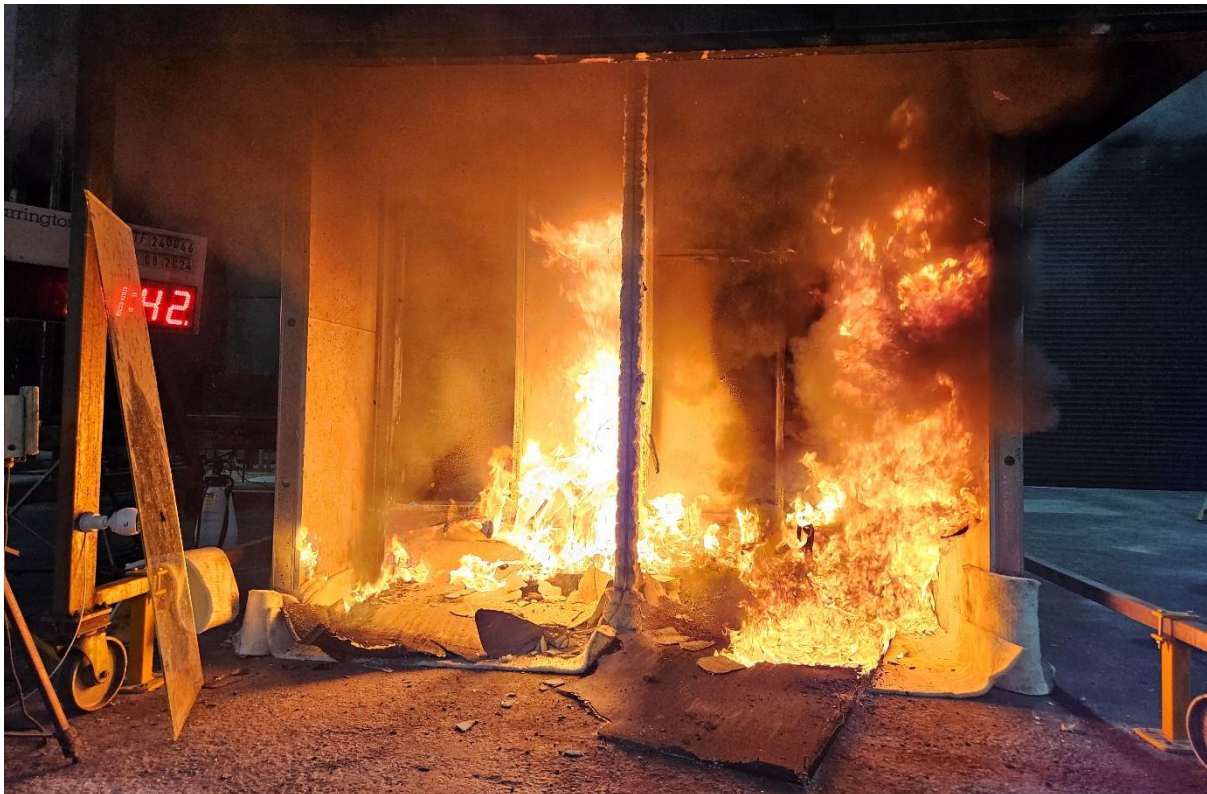
Figure 25 The specimen 31 minutes 42 seconds into the test (burner output at 300 kW)

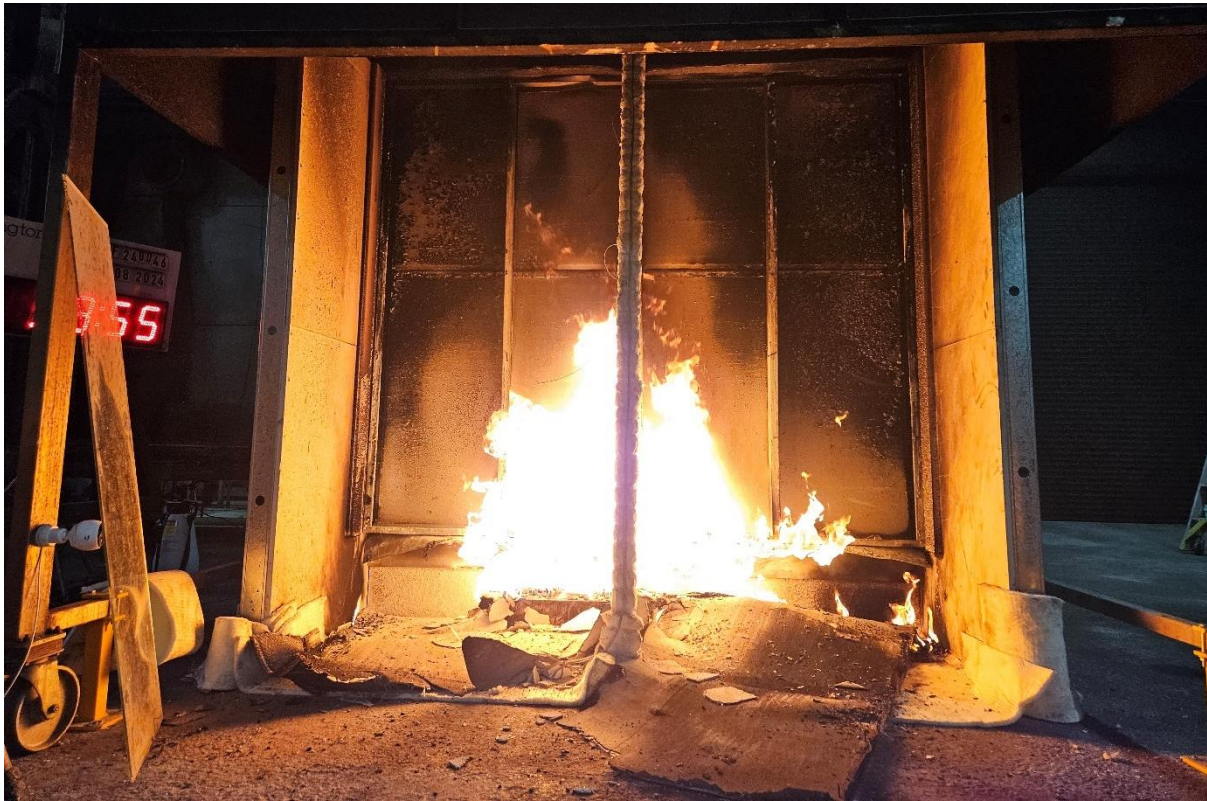
Figure 26 The specimen 39 minutes 55 seconds into the test (burner output at 300 kW)

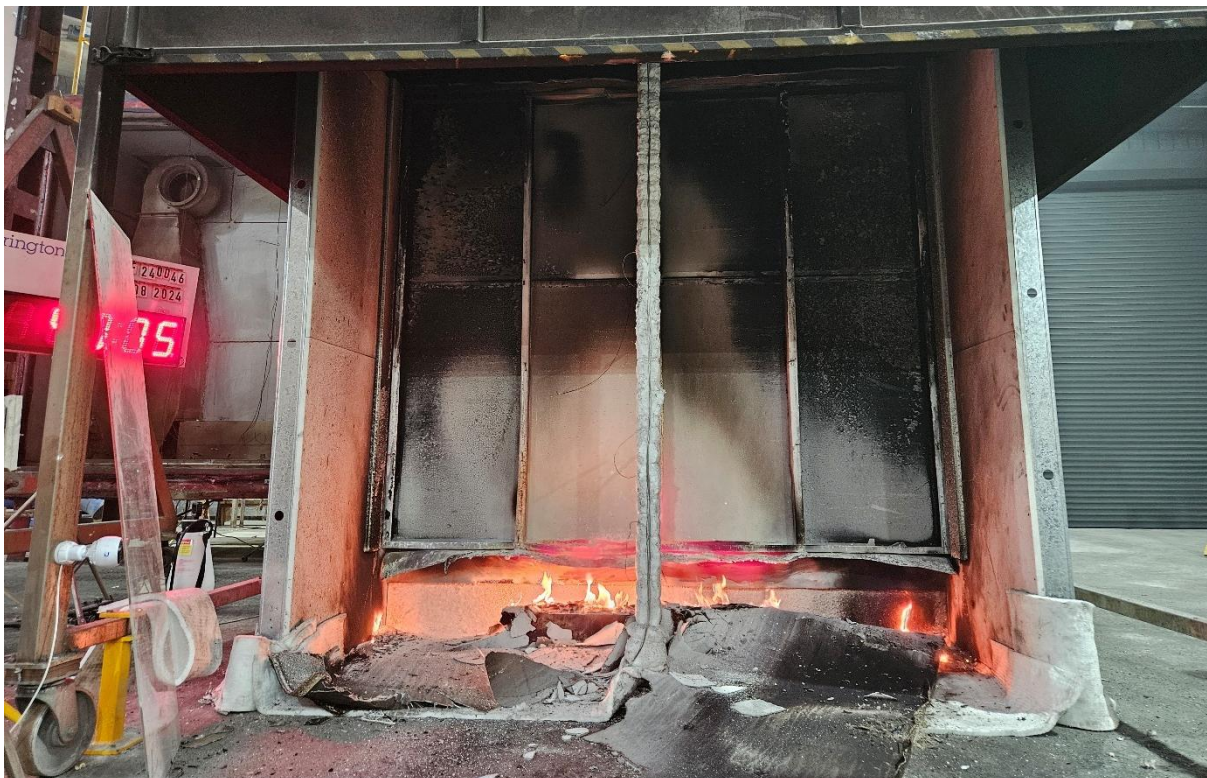
Figure 27 The specimen 40 minutes 5 seconds into the test (burner off)

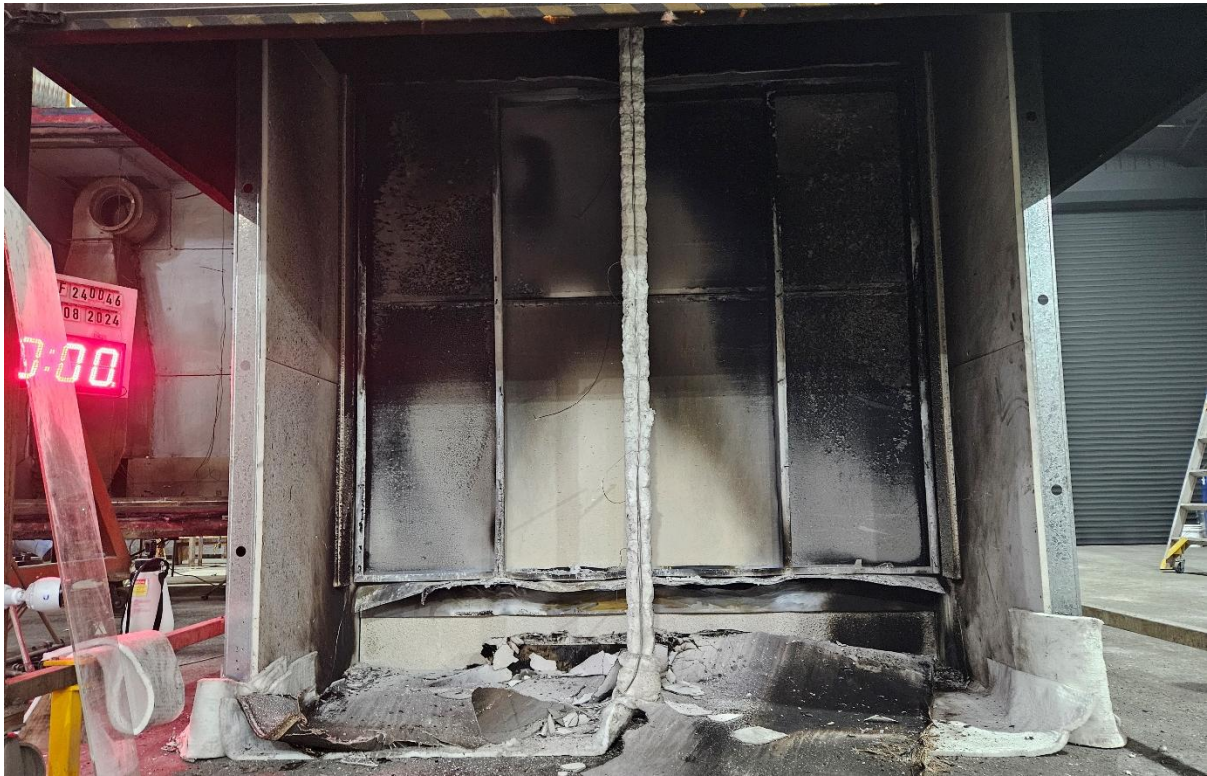
Figure 28 The specimen at end of the reaction to fire test – exposed side

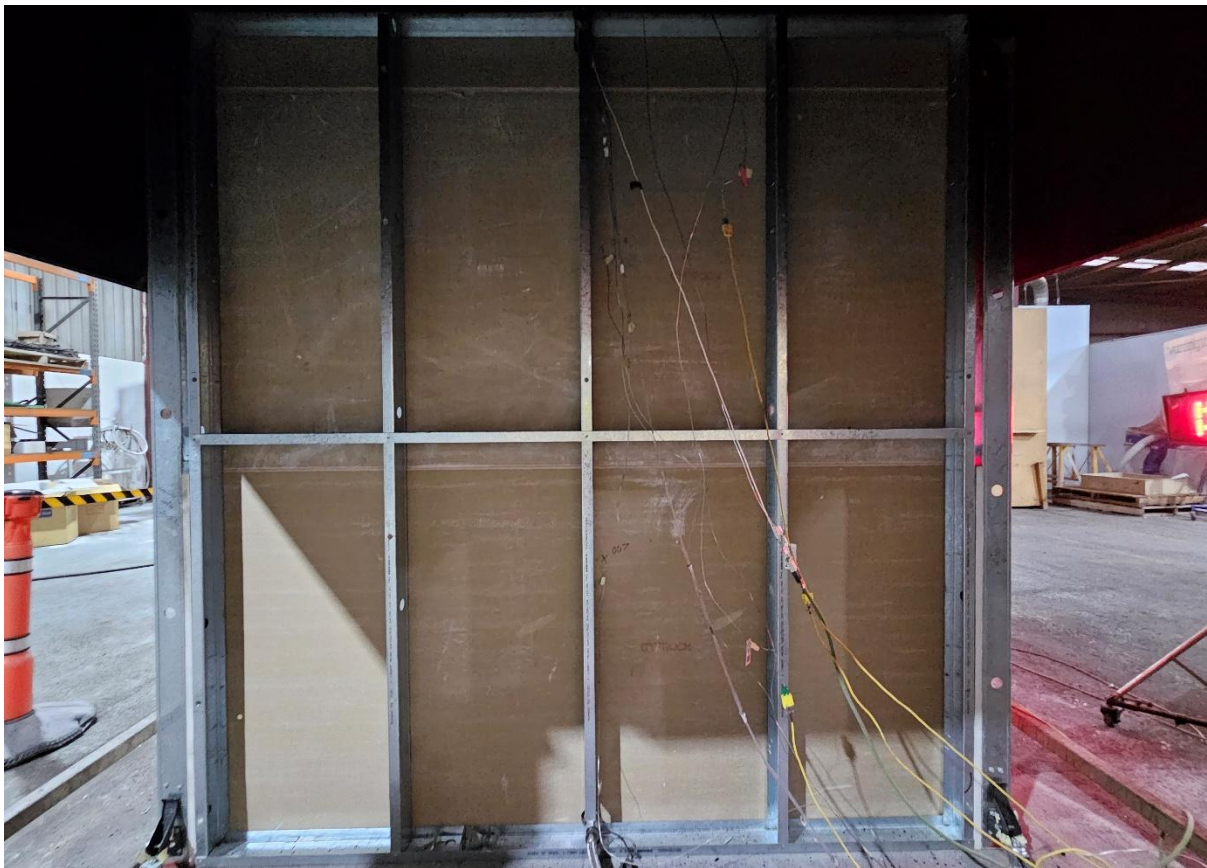
Figure 29 The specimen after the reaction to fire test – unexposed side
